Myers Field Airport (CNB)

December 2017

Since 1995, Federal grant assurances have required that to continue receiving Federal funding, airports implement a pavement maintenance-management program for any pavement constructed or repaired using Federal money. To help individual airports meet this grant assurance and improve the statewide airport system, the Minnesota Department of Transportation (Mn/DOT) Office of Aeronautics contracted with Applied Research Associates, Inc. (ARA) to provide pavement evaluation and management inspections at local airports. This report contains the results of the 2017 pavement inspections at Myers Field Airport (CNB).

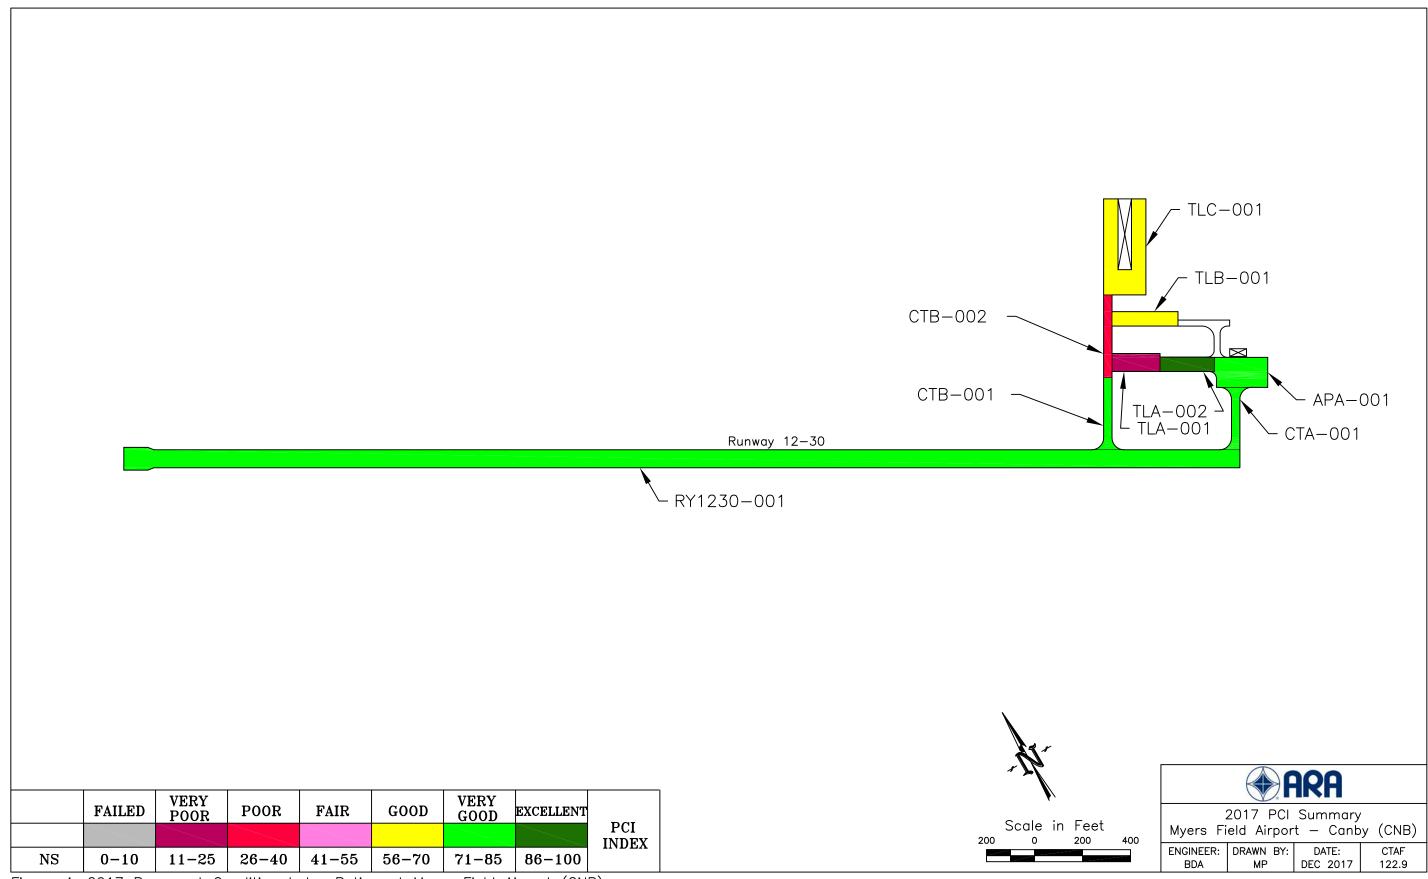
Figure 4. 2017 Pavement Condition Index Rating at Myers Field Airport (CNB).

⁶Greater than expected drop in PCI of 4.9 PCI/year due to fatigue failure of surface under repeated loading evidenced by medium-severity alligator cracking.
