Bridge 9103 Rehabilitation Study Final Report Red Wing, Minnesota

August 2013

Prepared by
HDR Engineering, Inc.
and
Gemini Research

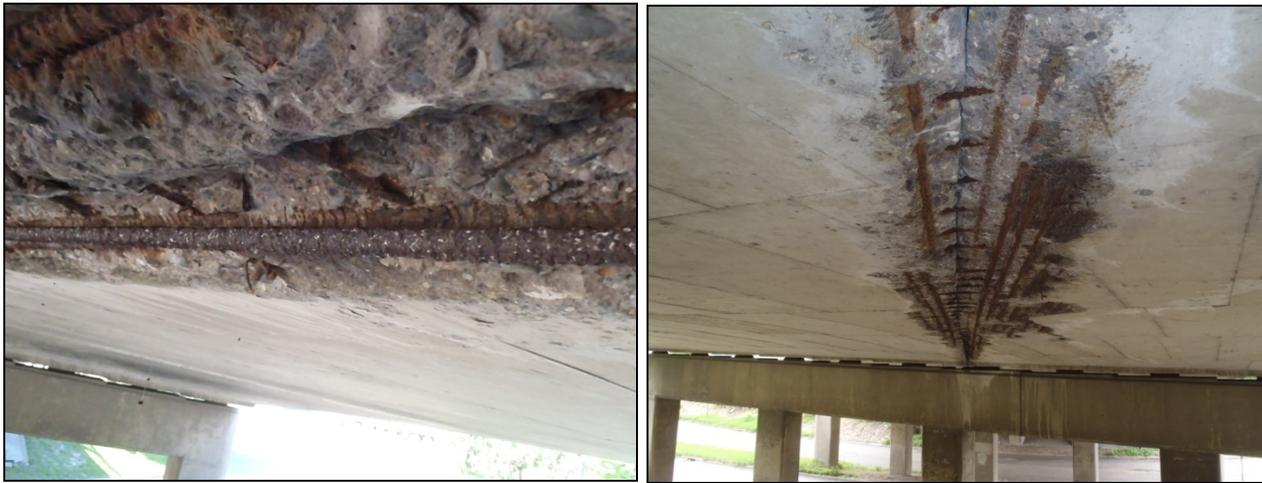
In some areas, the spalling and delamination of the concrete on the underside of the slab are so deep that the bottom reinforcing steel running parallel to TH 63 (longitudinal) is no longer bonded to the concrete. This is evident at 8 to 10 longitudinal bars in each of Spans 2, 3, 4, and 5 along most of their length. This steel is the main reinforcing steel in the middle of the spans. It is corroded and section loss has occurred all the way around many of the bars (Figure 8). Although 8 to 10 bars comprise only 5% to 6% of the total longitudinal bars, the affected bars are concentrated within a design strip width. Two exposed reinforcing bars that were completely debonded from the concrete were measured and found to have a remaining

diameter of approximately $\frac{3}{4}$ ". These bars were originally 1" in diameter, which equates to a 44% loss in cross sectional area. (See Section 7.0; see also Page 4 of Appendix G.)

Figure 8. Exposed and debonded reinforcing in Span 3.

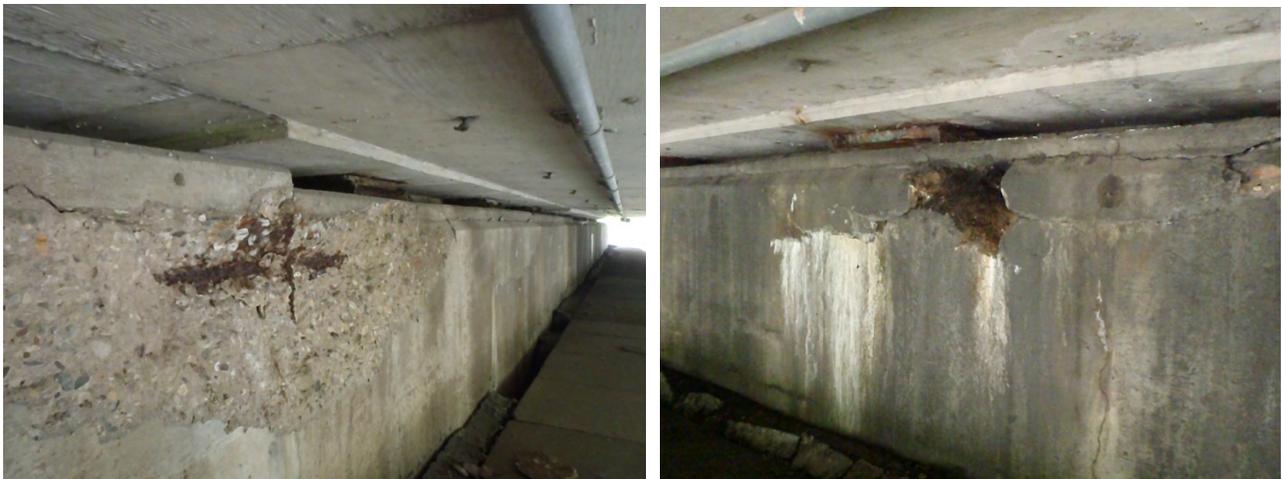
The abutments have vertical cracks with some leaching in the front face. Both abutments also have areas of delaminated concrete on the front face, which measure approximately 8 square feet and 70 square feet for the south and north abutments, respectively. The south abutment has spalled areas that measure approximately 12 square feet, and the north abutment has random and horizontal cracking that measures approximately 35' in length. Typical examples of the deterioration found on both abutments are shown in Figure 9. The slope paving in front of the North Abutment has several areas of severe settlement, up to 12" in depth. According to inspection records, the settlement and erosion at the north abutment began at least five years ago but it is unclear if it has stabilized or getting worse.

Figure 9. Spalled and delaminated concrete on the north abutment.

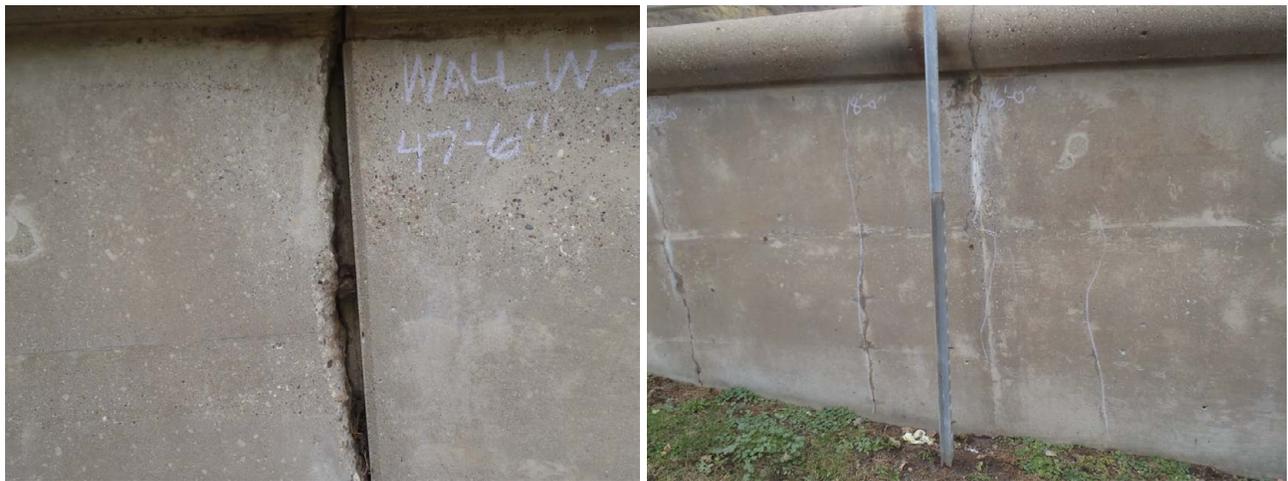
Figure 10. Typical spalls and cracks in the approach retaining walls.

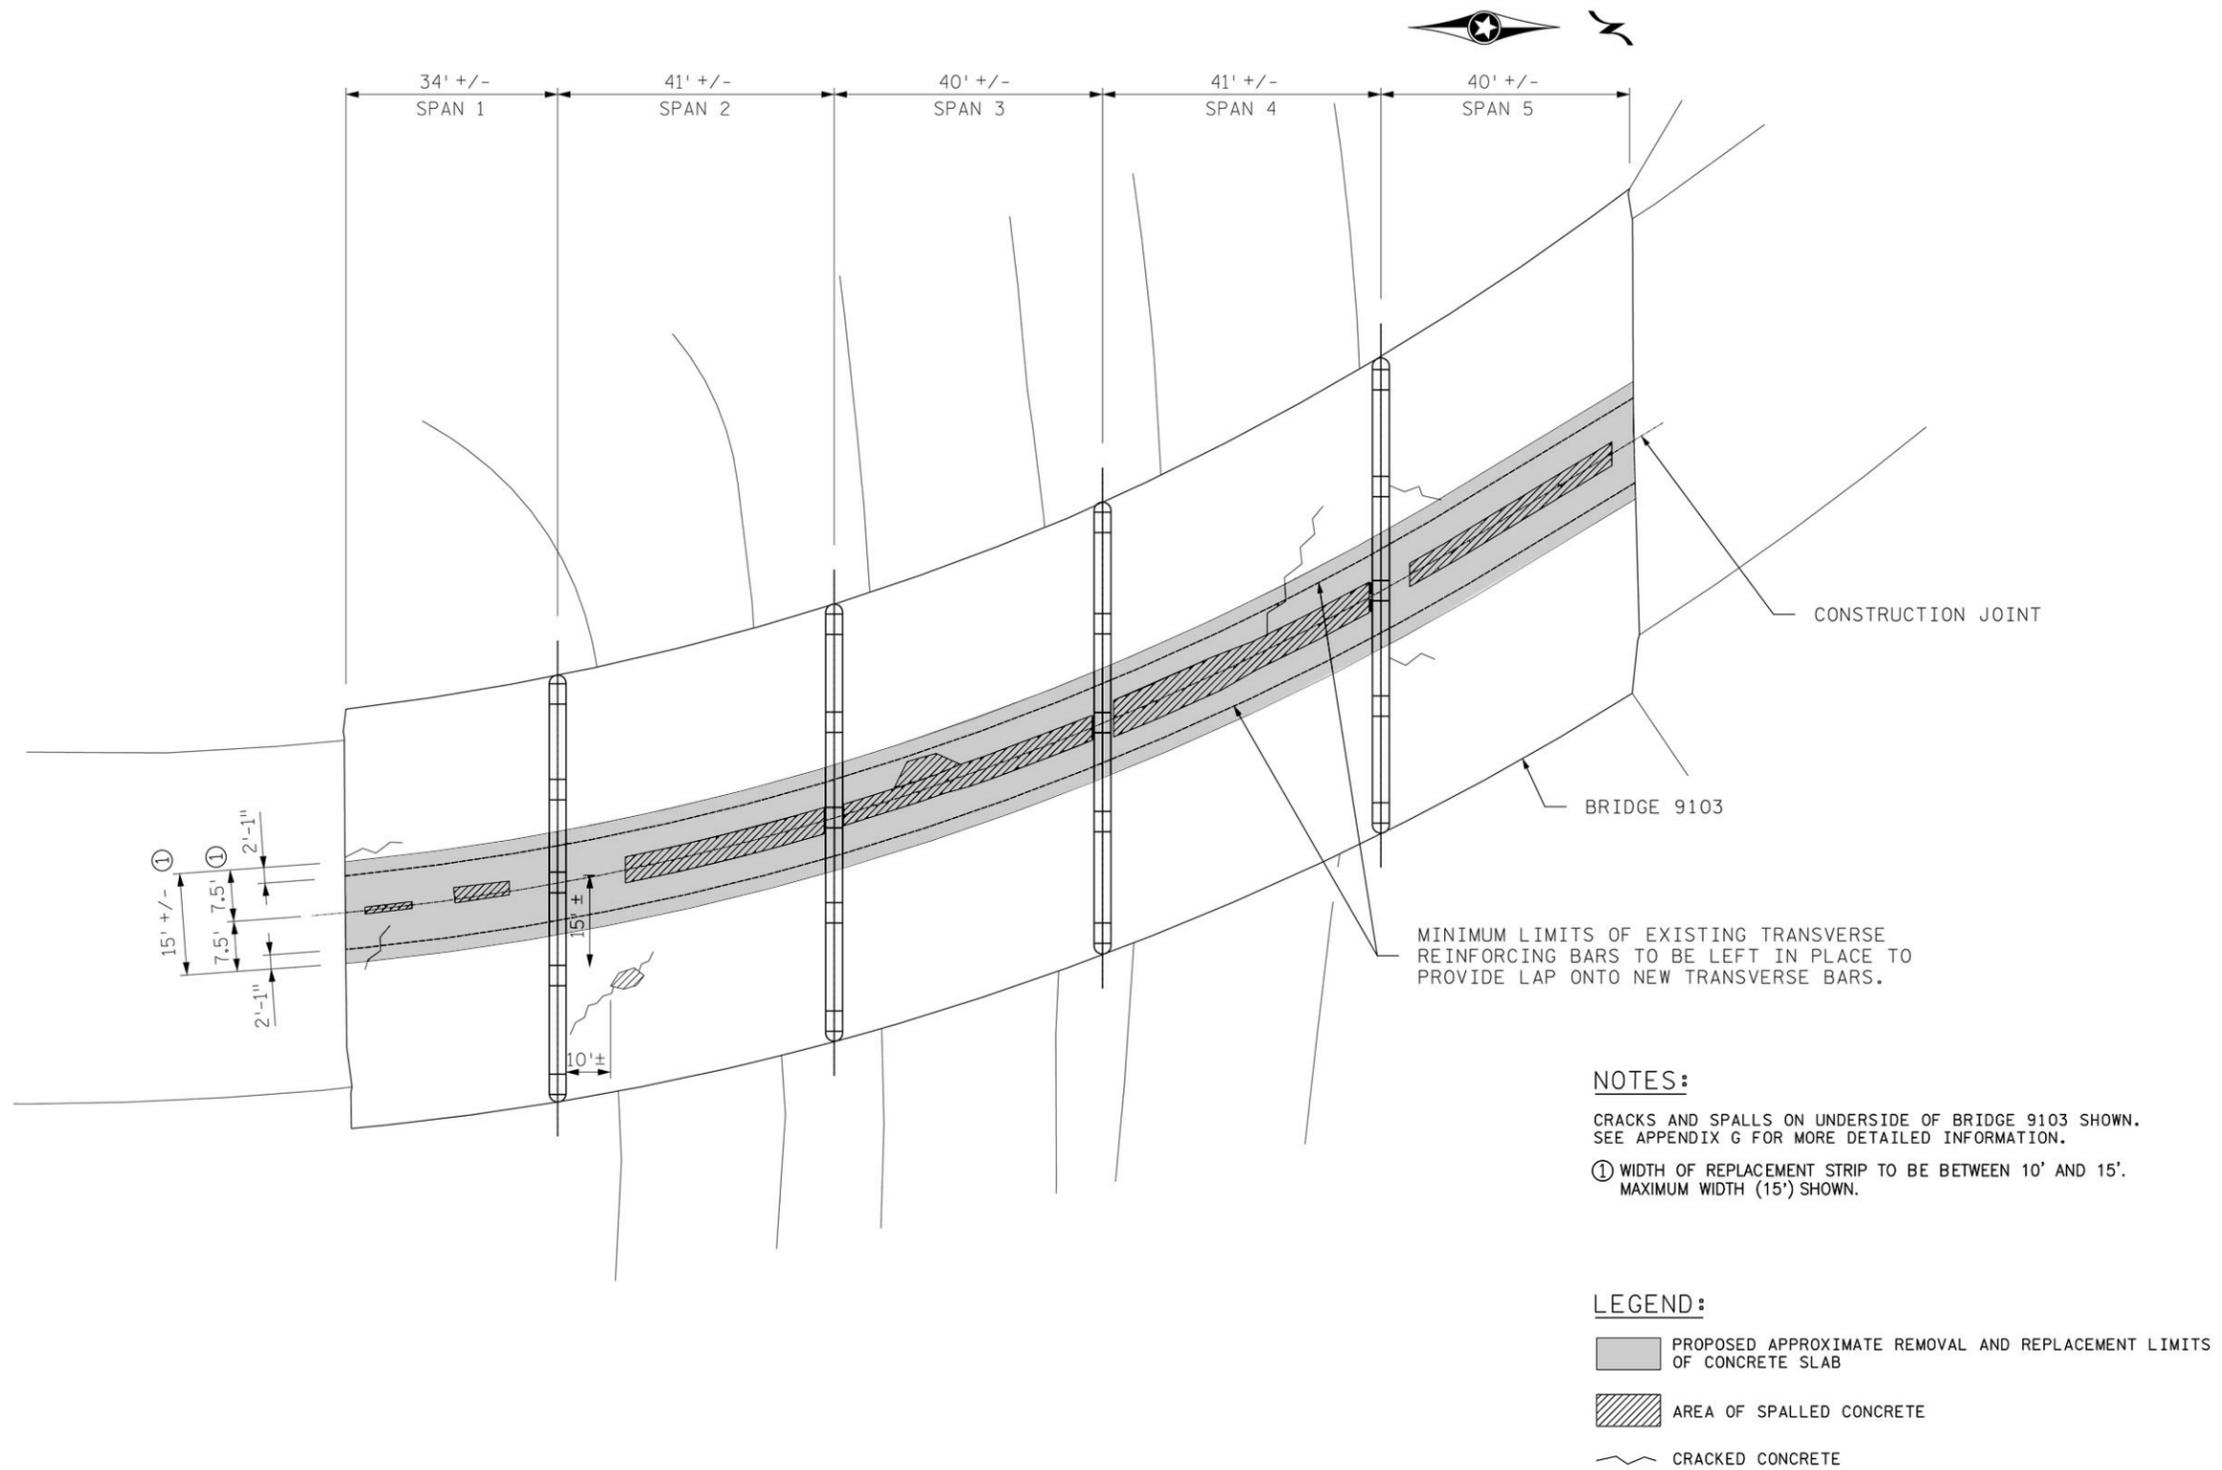
All of the areas of cracks, spalling and delamination have been mapped on a plan view of the bridge on Sheet 1 and 3 in Appendix G. All of the exposed reinforcing steel and the remaining diameter of several exposed bars have been recorded on Sheet 2 in Appendix G. The mapping of the areas of spalling and delamination was accomplished by visual inspection and by sounding the entire underside of the slab with a hammer from a bucket truck. When areas of sound concrete are hit with a hammer they make a solid "ping" sound while delaminated concrete makes a hollow "clunk" sound.

Figure 11. Plan view showing existing cracking and spalling of concrete slab on underside of Bridge 9103 and the approximate limits of removal and replacement for Alternatives 1 and 2 (HDR drawing).

It is recommended that the replaced strip be a constant width for several reasons. The first is based on how the continuous concrete slab functions, as described above. If the removed strip is wider in one span than in an adjacent span, the redistribution of loads would cause the dead load being carried by the adjacent span to be greater than was originally intended. Secondly, a constant-width strip helps maintain the continuity of the reinforcing bars. Varying the width would cause the cut line for the removal to cross the longitudinal reinforcing steel, potentially at sharp angles. This would make it very difficult or not possible to lap onto existing longitudinal bars. Construction would be complicated and time consuming for the contractor, requiring field-cutting of numerous reinforcement bars to fit varying widths and lengths of deck replacement. Although using a variable-width strip would remove slightly less material, all of the construction operations (i.e., concrete removals, erecting falsework, forming, reinforcement placement, and finishing the concrete) would still be required regardless of the removal width at any particular location. There would not be any time savings, and, in fact, constantly varying the width would delay the construction crew as they would have to continually stop and assess the limits of removal. The inefficiencies would offset any savings from decreased quantities of concrete and reinforcing.

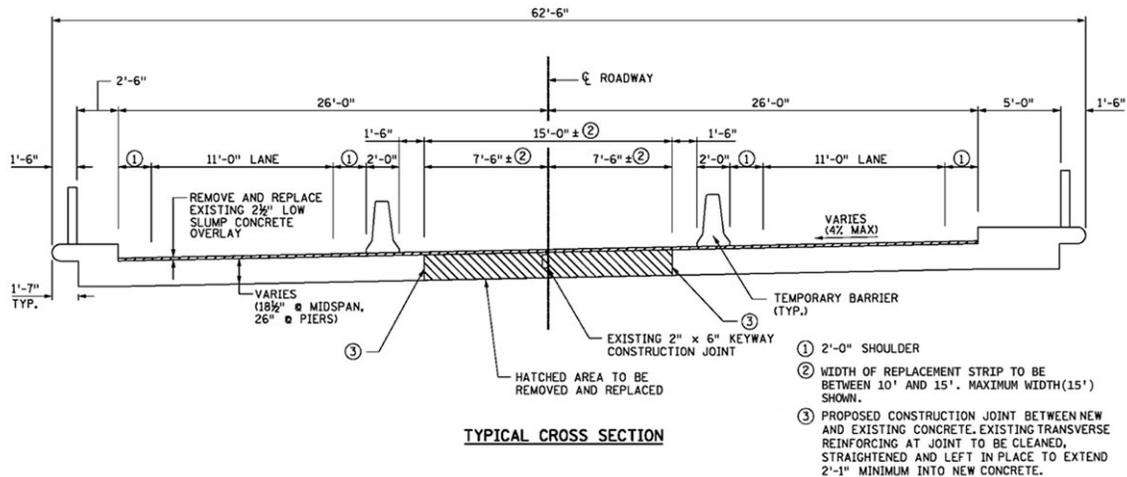
Figure 12. Approximate concrete slab removal and replacement limits for Alternatives 1 and 2 with possible lane configuration for maintaining traffic (HDR drawing).

In addition to replacement of the center 10'- to 15'-wide strip, Alternative 1 would patch spalled areas of the slab outside of the removal limits and epoxy inject all cracks. Expansion joints at the ends of the deck would be replaced with new strip seal joints. The map cracking and chloride content in the slab's overlay (noted in Sections 5.2 and 5.3) has reduced the overlay's effectiveness in protecting the structural concrete slab from the ingress of chlorides, therefore the deck's 2½" low-slump concrete overlay would be replaced on the entire width of the bridge. A MnDOT-approved crashworthy end terminal would be added to the bridge approach guardrail.
