**“IT’S JUST A SIMPLE MILL AND
OVERLAY”**

17th Annual TERRA Pavement Conference

Matt Oman, PE – Braun Intertec

Cory Slagle, PE – Washington County Public Works

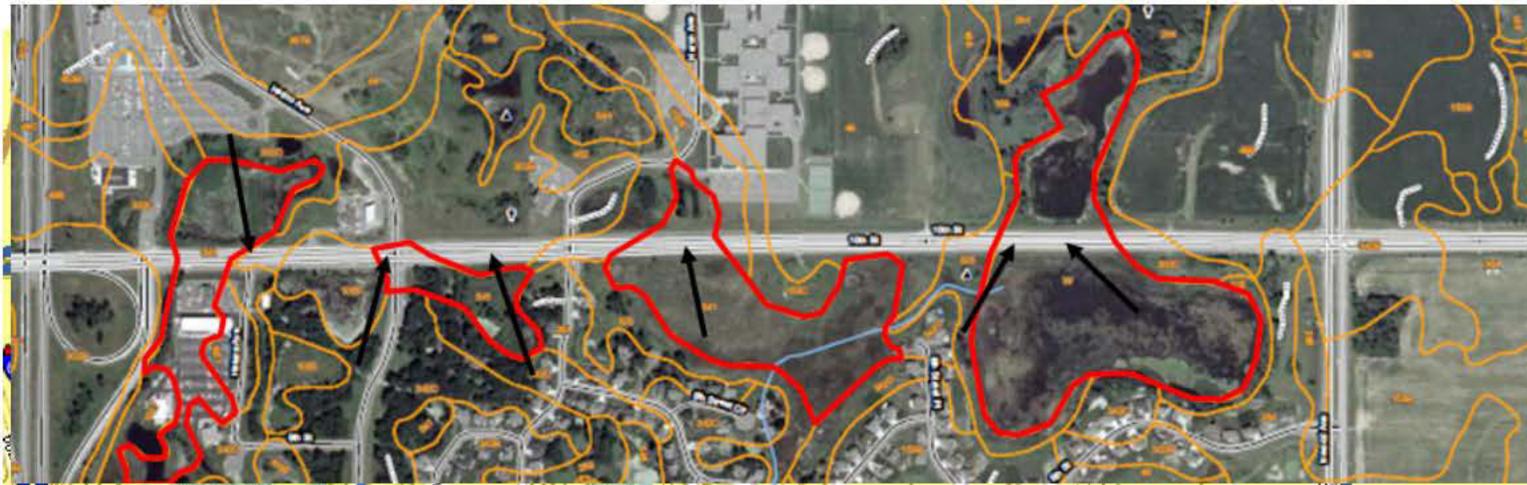
Our Opinions After Field Review

- ❑ Standing high water levels were noted in the catch basins. Several outlet pipes were plugged.
- ❑ Definitely a subsurface issue

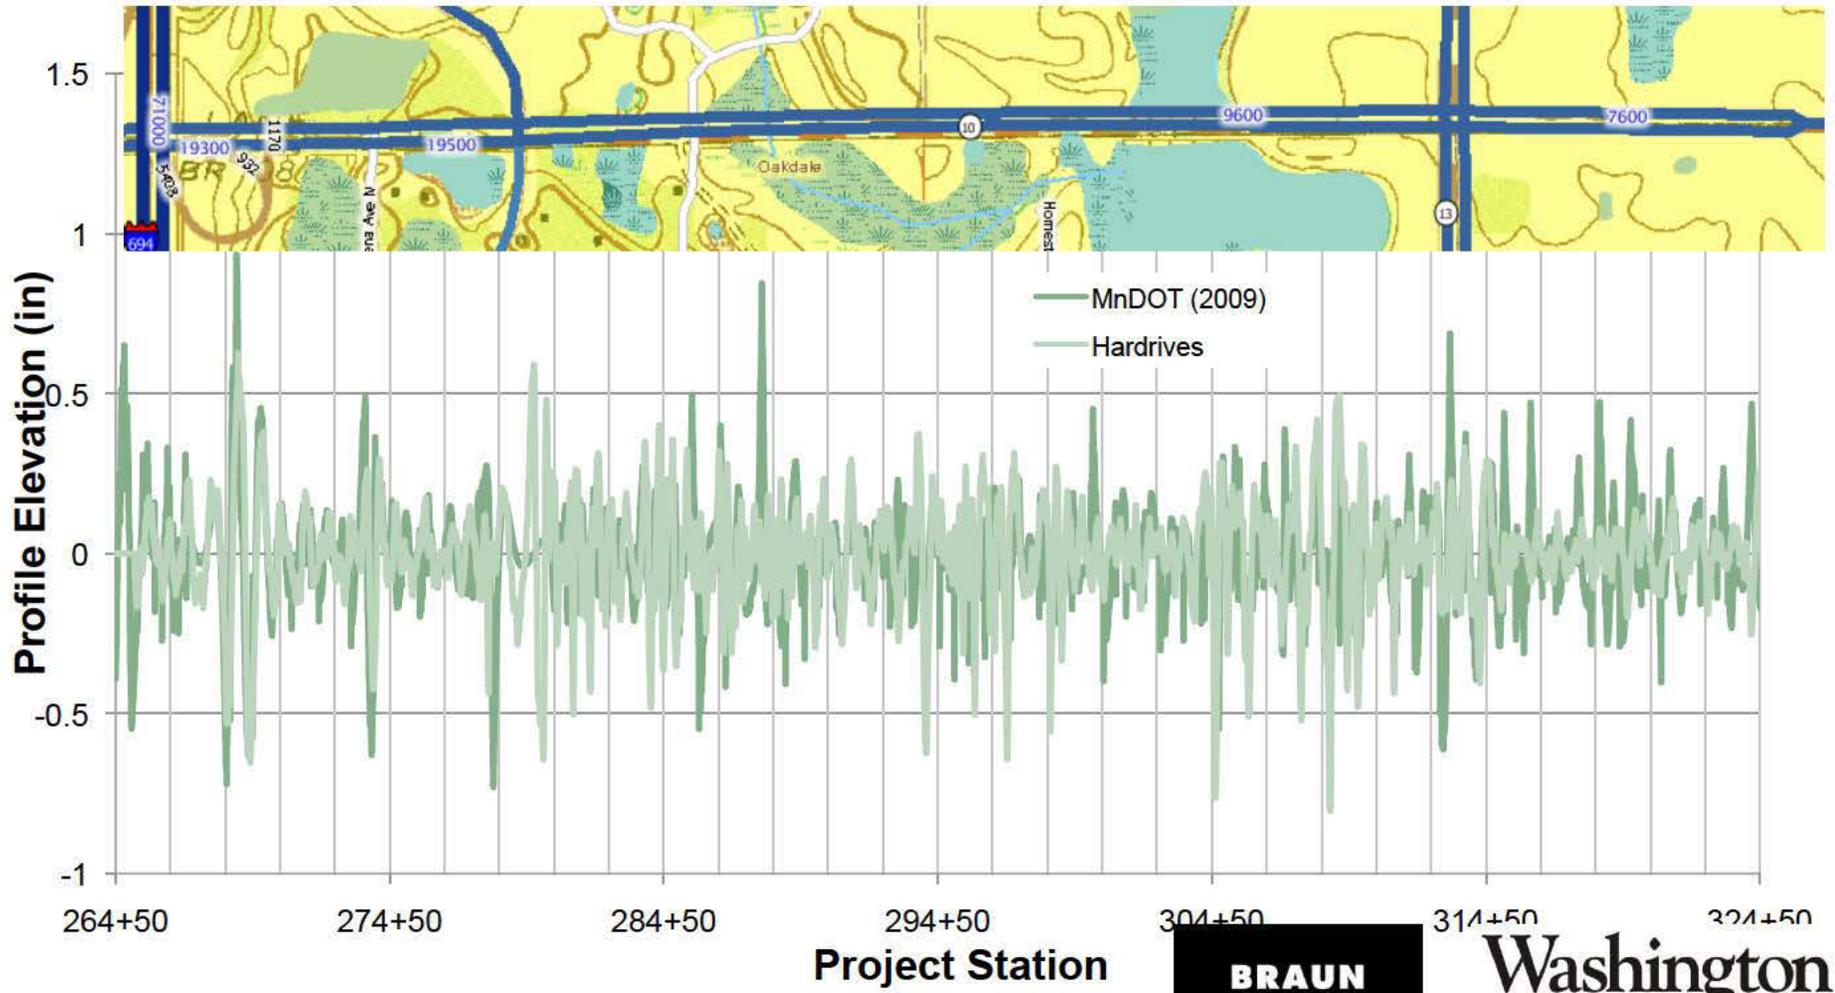
Synchronized EB 2009 & 2012¹

- ❏ Soils Maps
- ❏ Construction Plans (w/ muck profile/x-sections)
- ❏ Previous MnDOT Pavement Management Data
 - ❏ 2005 – IRI ~116 in/mi.
 - ❏ 2009 – IRI ~ 150 in/mi.
 - ❏ 2012 – IRI estimate ~180 in/mi (+10 in/mi/yr historical)
- ❏ 2010 FWD
 - ❏ approximately every one-tenth of a mile
 - ❏ backcalculated R-values generally lower in the EB lane
- ❏ 2012¹ Contractor IRI²
correction

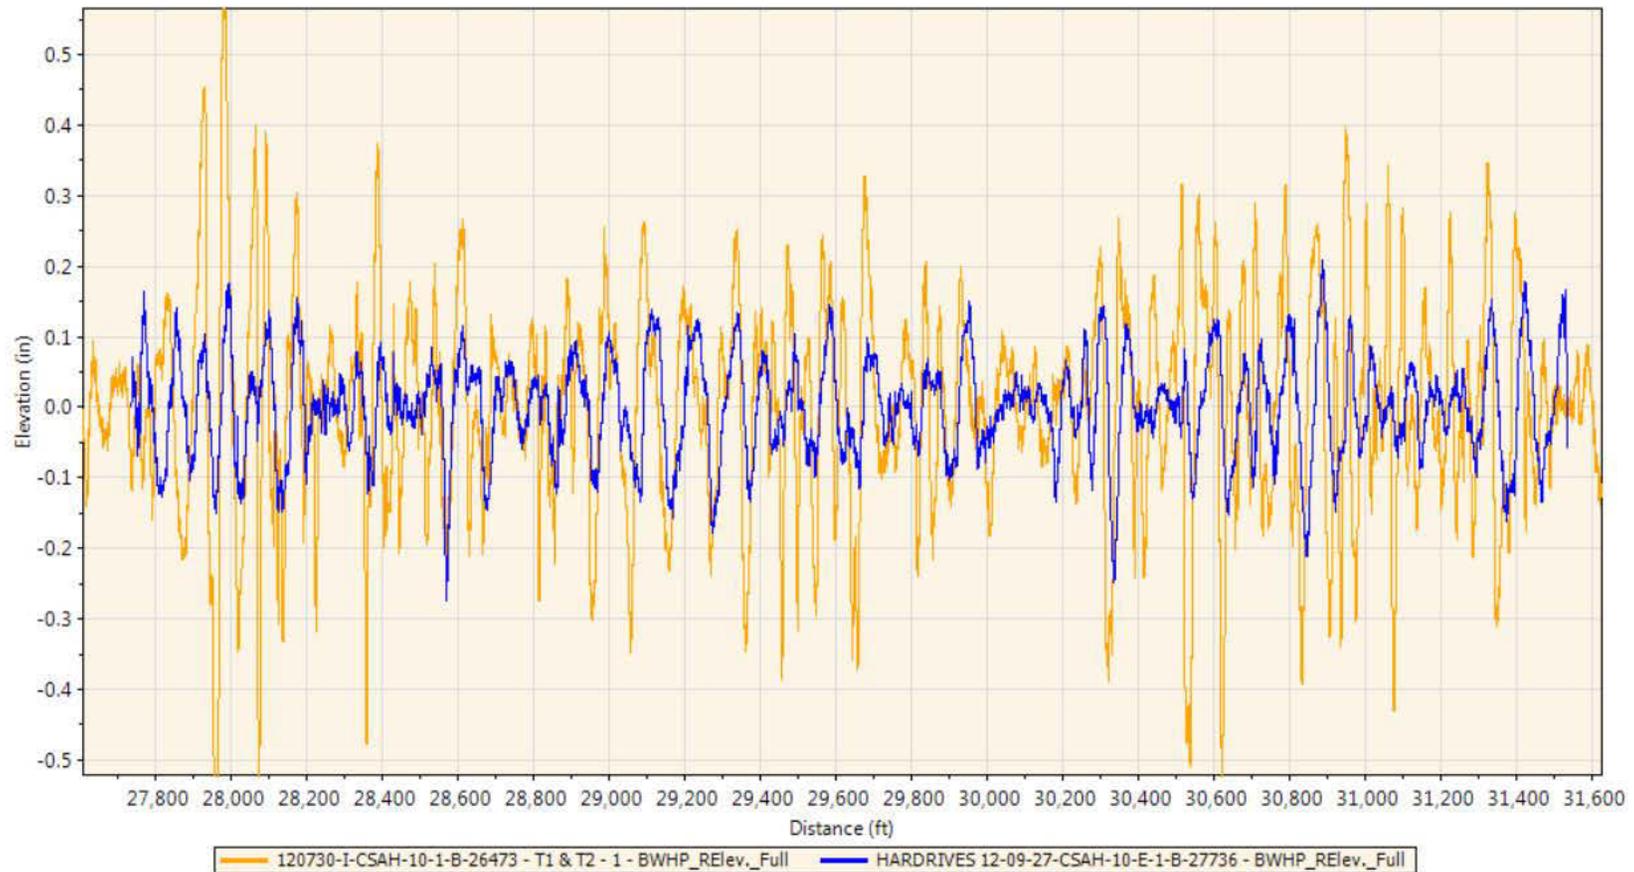
Correction – Pre- & Post-Profile

- Ⓜ **Density:** Not greatly sacrificed. The six Contractor cores extracted indicated densities of 89.8% to 95.9% (average = 91.6%).
- Ⓜ **IRI:** *If* evaluated as % Improvement project, would have earned incentive (> 64% is

Lane	Location	Pre-Correction IRI	Post-Correction IRI	% Improvement	Ave % Improvement
Driving (right)	Left WP	149	80	46	55
	Right WP	123	46	63	
Passing (left)	Left WP	115	68	41	50
	Right WP	113	45	60	
Overall Percentage Improvement					52
