UNDERWATER BRIDGE INSPECTION REPORT

STRUCTURE NO. 27B60

LOWRY AVENUE

MINNESOTA DEPARTMENT OF TRANSPORTATION
UNDERWATER BRIDGE INSPECTION

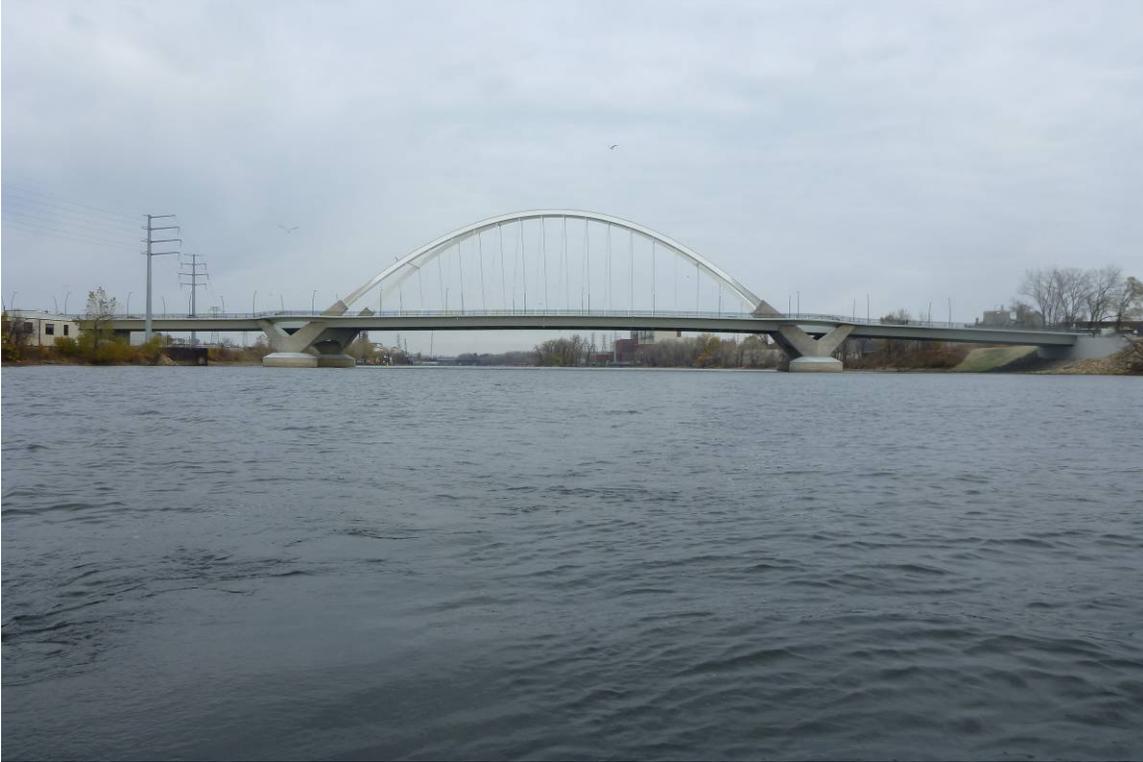
Photograph 1. Overall View of the Structure, Looking North.

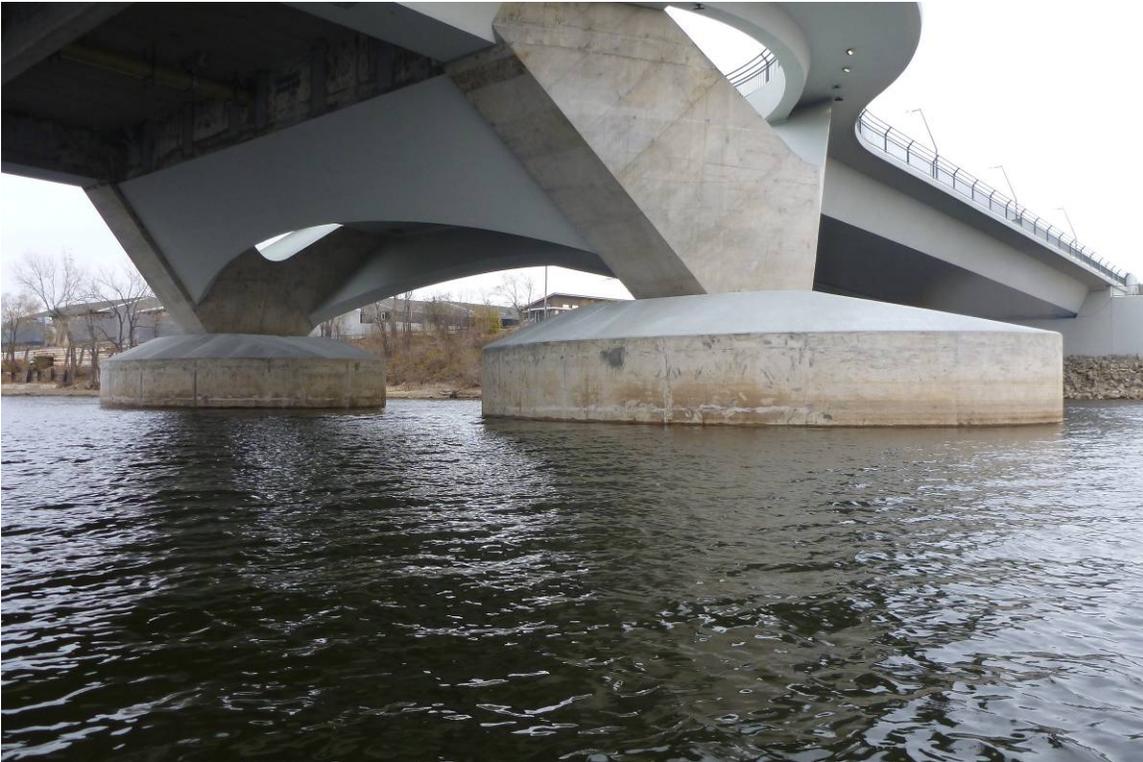
Photograph 2. View of East Pier, Looking Northeast.

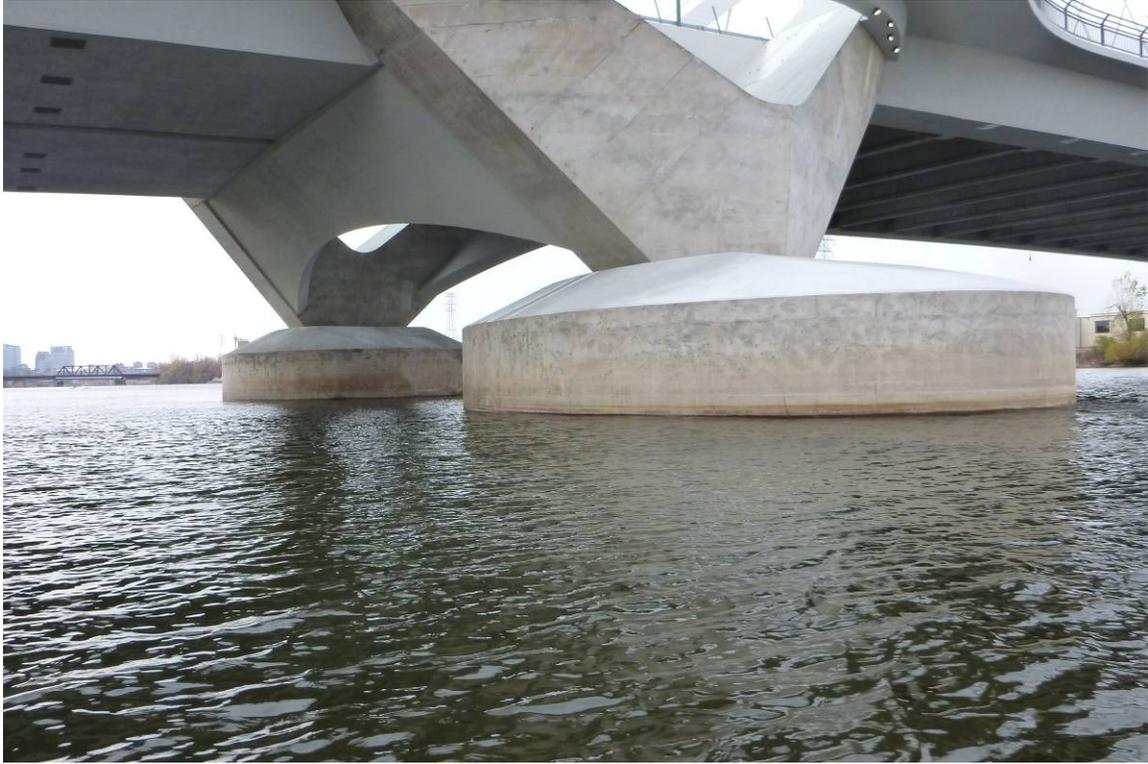
Photograph 3. View of West Pier, Looking Southwest.

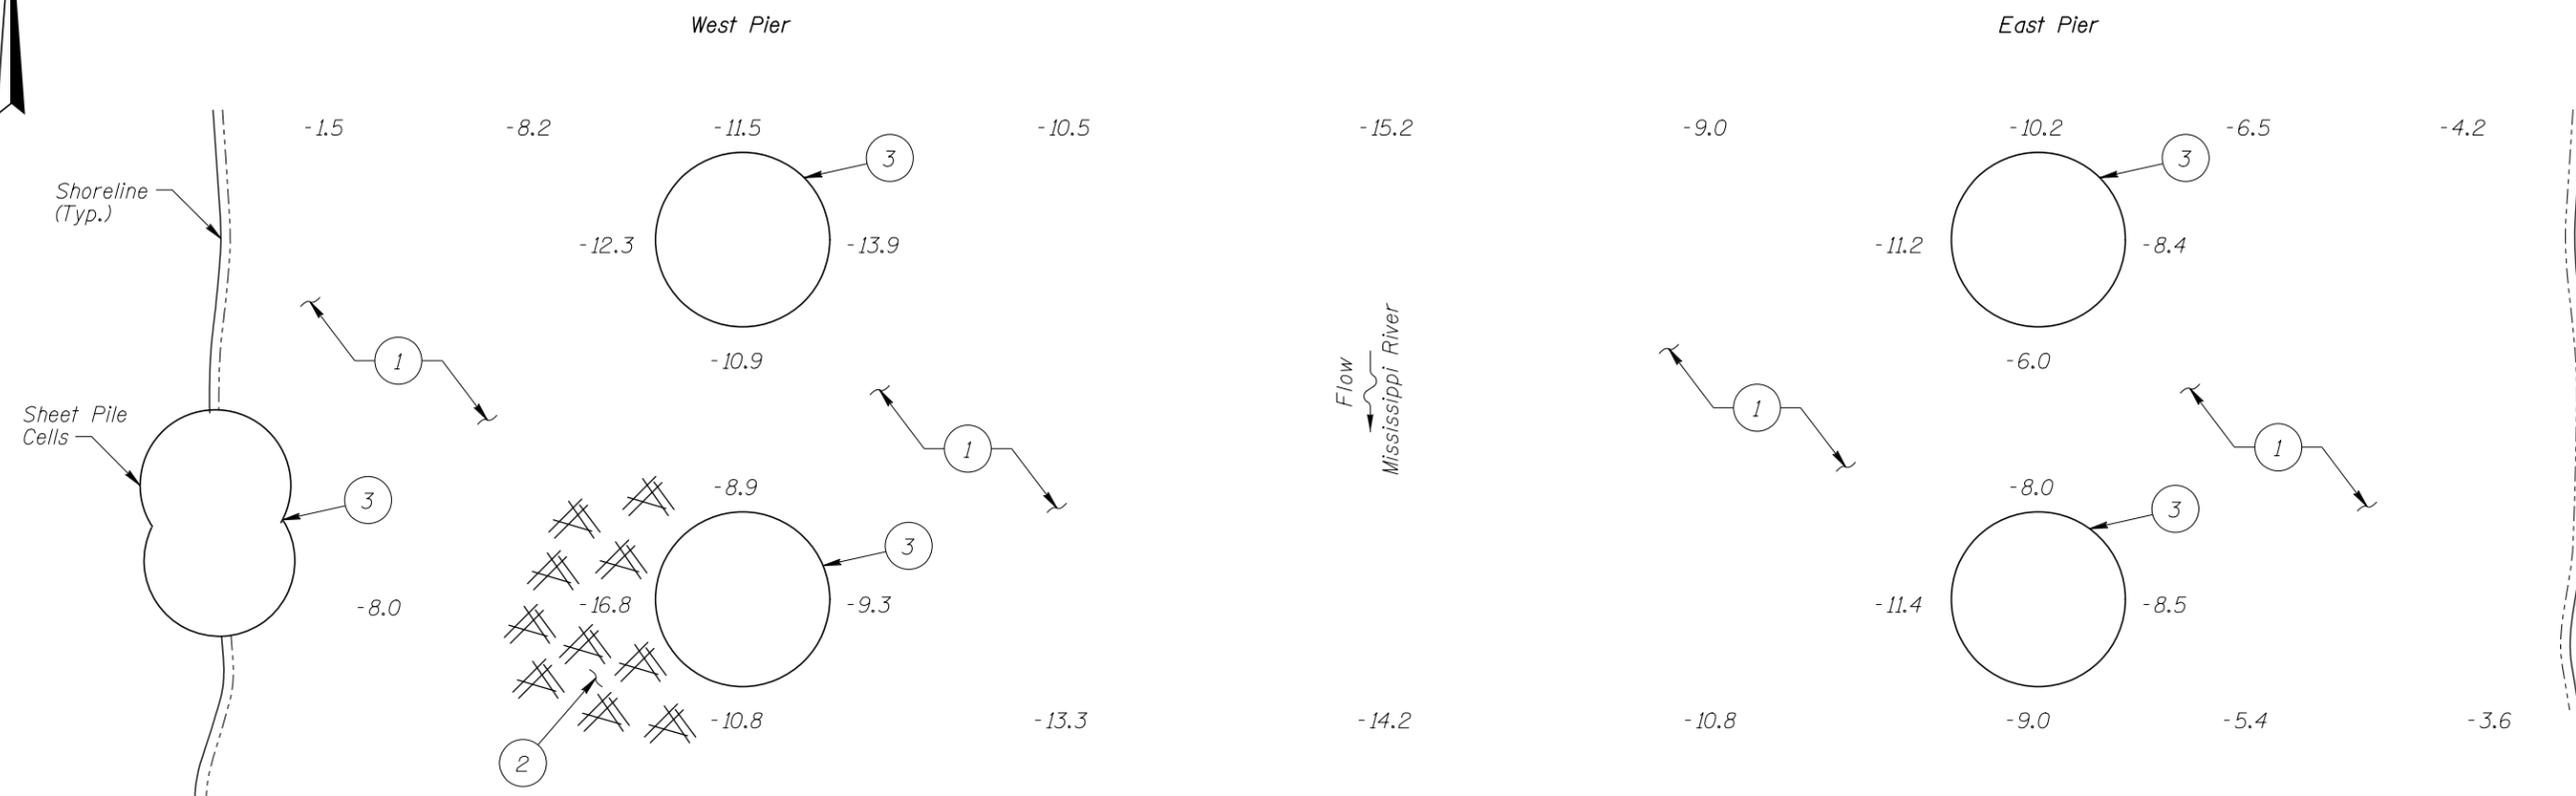
SOUNDING PLAN

- 1 The channel bottom material consisted of sandy gravel and cobbles allowing up to 4 inches of probe rod penetration. Scattered construction debris was observed on the channel bottom around both piers.
- 2 A moderate to heavy accumulation of timber debris, consisting of up to 12 inches diameter logs and timber piling, was observed along the west face of the downstream cell of the West Pier, extending from the channel bottom to the waterline.
- 3 Concrete surfaces were smooth and sound. The steel sheet piling of the cofferdam was in like-new condition and exhibited no appreciable corrosion.

- (A) Monitor accumulation of timber debris during future inspections, and if found to be increasing to an excessive extent, removal operations may become warranted at that time.
