**Bridge Number: L8921
16th Ave. S**

FINAL MIDTOWN CORRIDOR INDIVIDUAL BRIDGE SUMMARY AND MANAGEMENT PLAN

Executive Summary

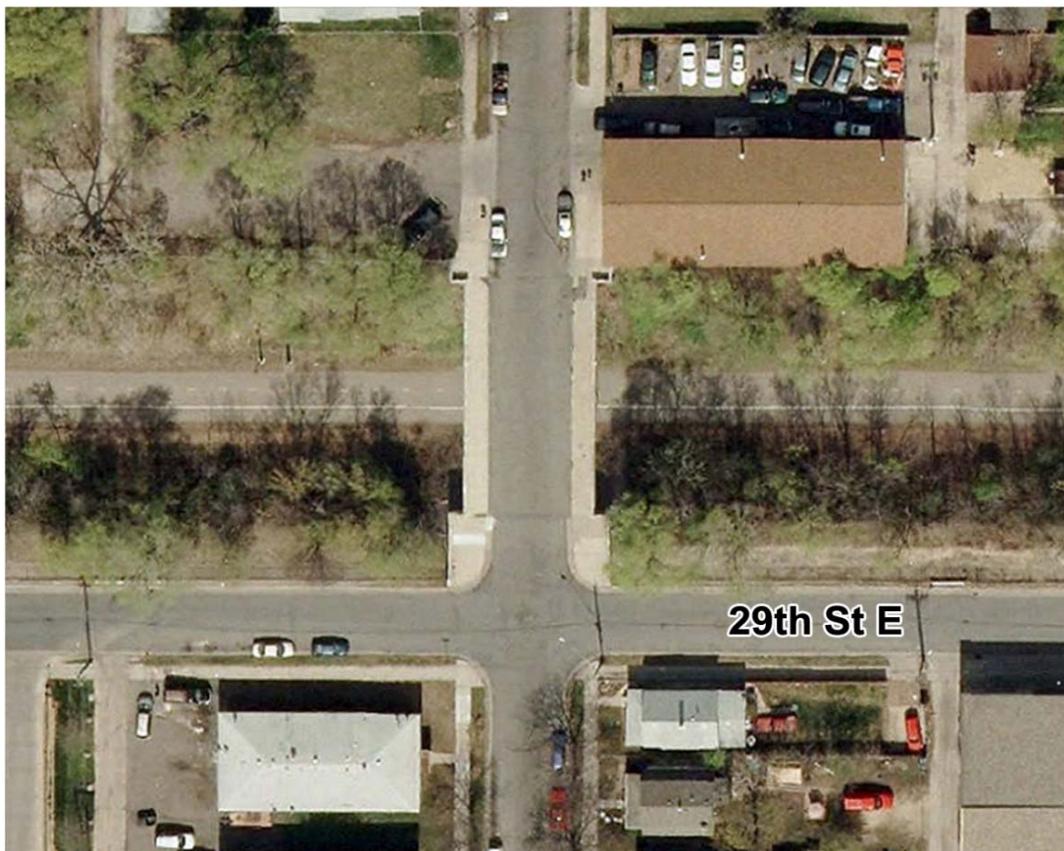
Hennepin Co. aerial 2012

Below is an aerial view of Bridge L8921 to provide an understanding of the physical context of the bridge.

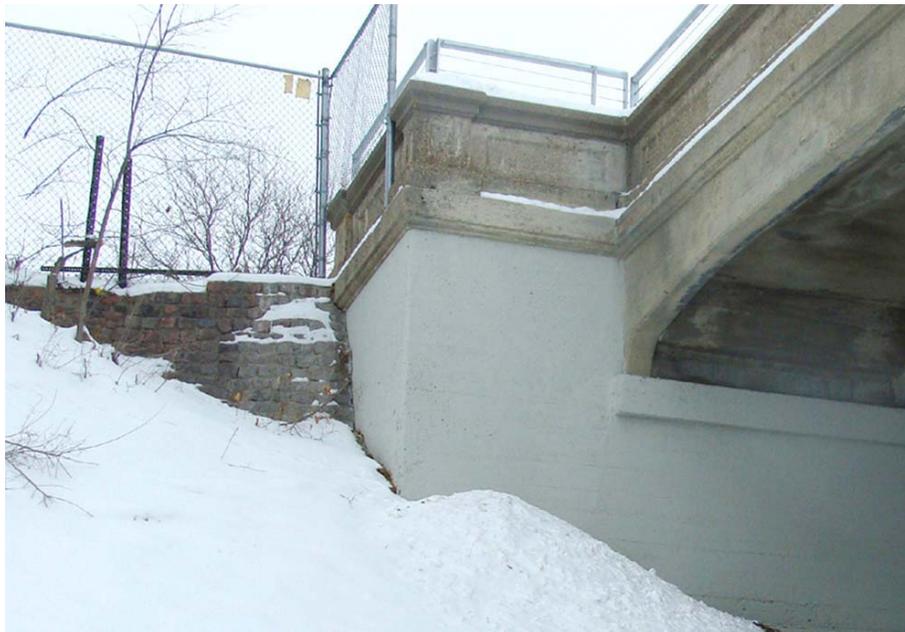
Attached to the northwest corner of the bridge is a coursed stone and brick retaining wall that was probably built in the early 20th century to support private property.

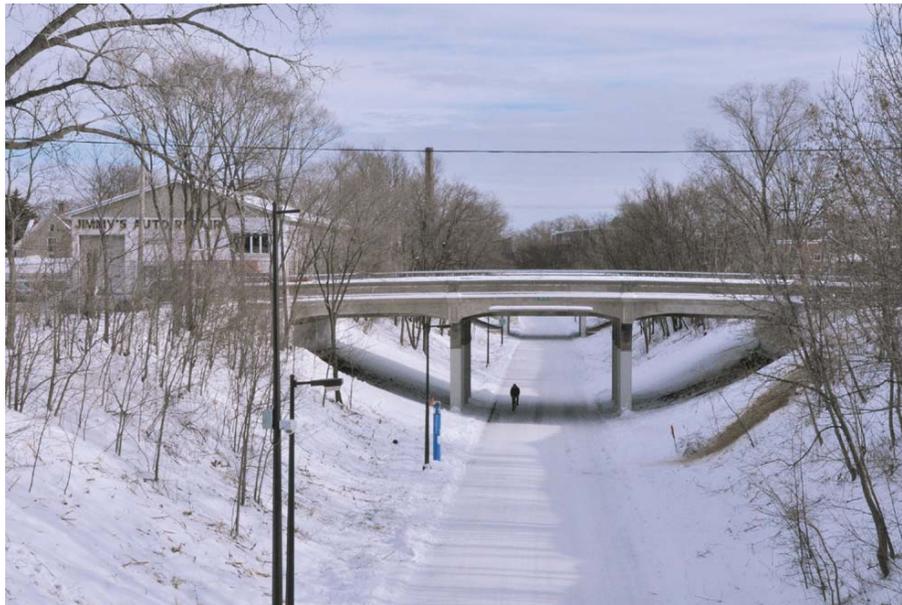
Feature 1: Reinforced concrete three-span bridge carrying a city street and raised sidewalks over a railroad trench 110-120 feet wide and 22 feet deep with moderately sloping sides. Neoclassical Revival design shared by 26 bridges (originally 37). From both below and on top of the bridge, views of the trench and closely spaced identical bridges create visual continuity; the three spans create a tunnel-like effect.

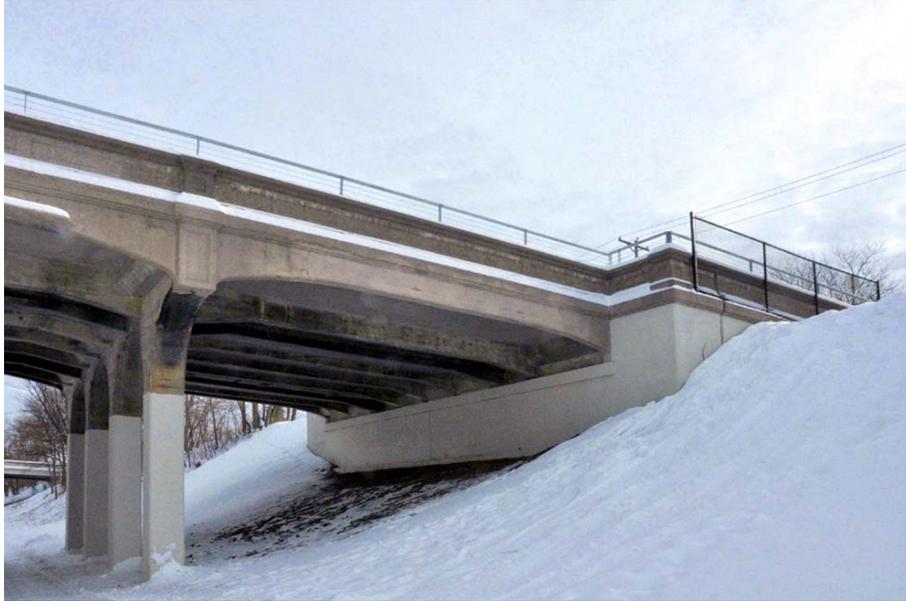
Feature 2: Abutments with classical coping on bridge seats and date block imprints. Piers comprised of four square columns joined by rounded arches that extend to the fascia to support cantilevered sidewalks. Multiple beams integrated with the deck; beams are angled to follow the curve of the fascia beams. Fascias are haunched with recessed panel detailing over the piers and smoke shields above the center span.

There are no structural preservation alternatives for this bridge. But, if funding is available, an additional historic element should be reconstructed to improve the overall historic integrity of the bridge. Concrete smoke shields were originally present over the center spans on the outside of both fascia girders; only one remains. The second smoke shield should be reconstructed. Details can be found in the original plans.

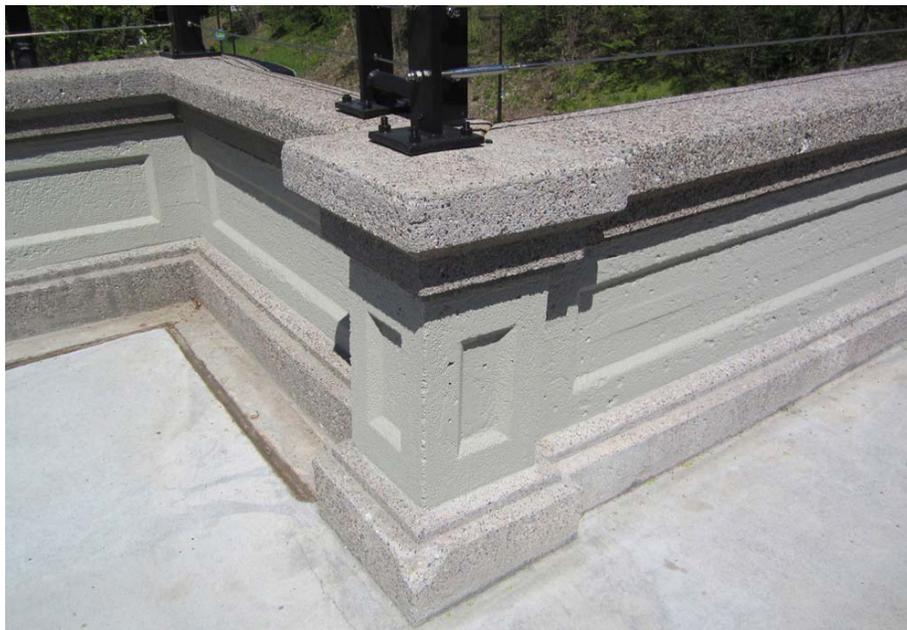
Feature 3: 36-inch tall concrete railings with both posts and panels divided into classical base, shaft, and capital. Simple recessed panels. Railings move apart laterally, tracing the edge of the abutments; sidewalks widen correspondingly.

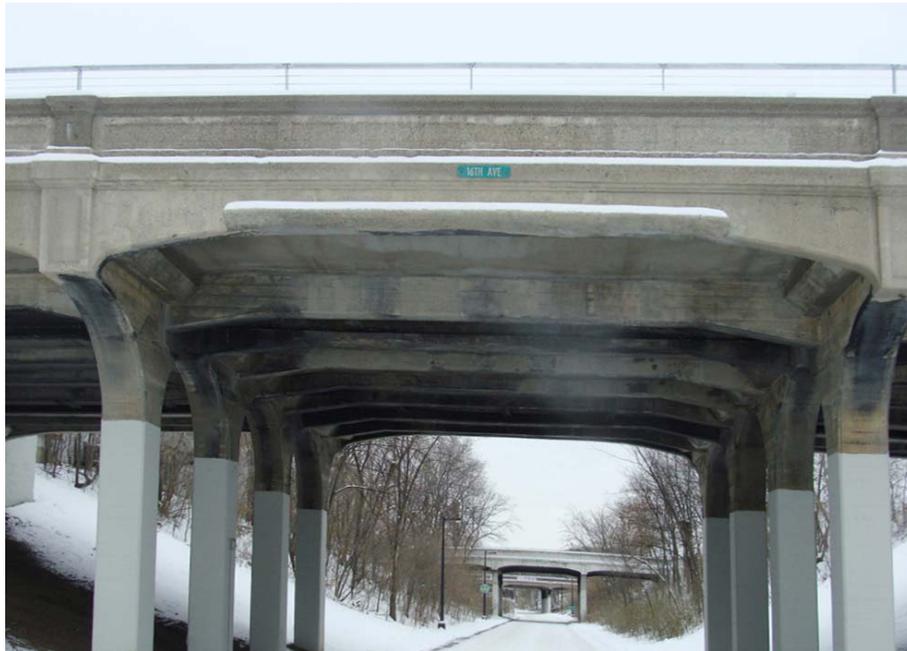
Feature 4: Unpainted concrete surfaces (some now painted) with board form lines on abutments, piers, beams, and underside of the deck; smoother finish on fascia and railings.

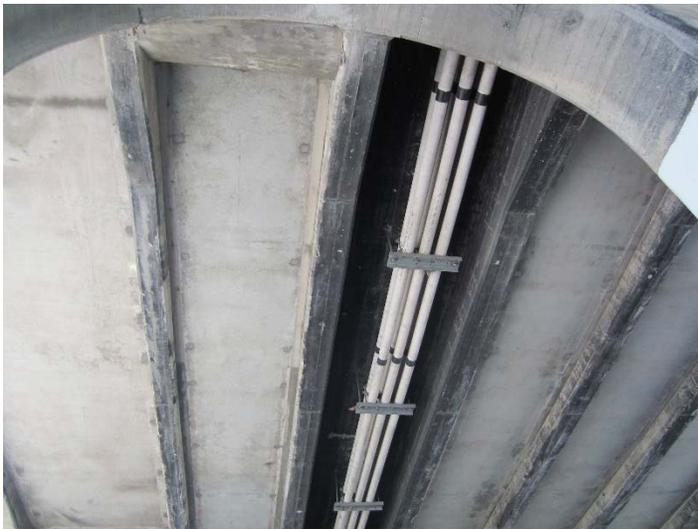
Superstructure:

Precast concrete panels were installed in each of the bays except where utilities are located.

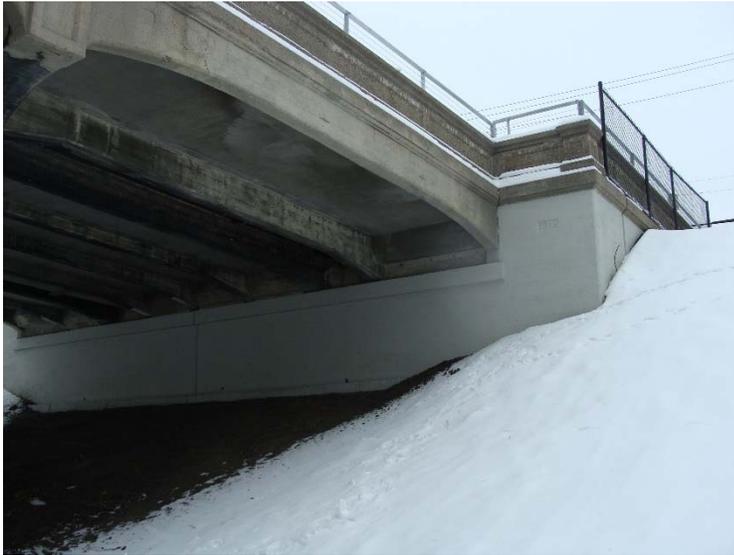
Substructure:

Cracks at the wing walls were repaired. Issues with settlement were stopped with the installation of helical anchors.

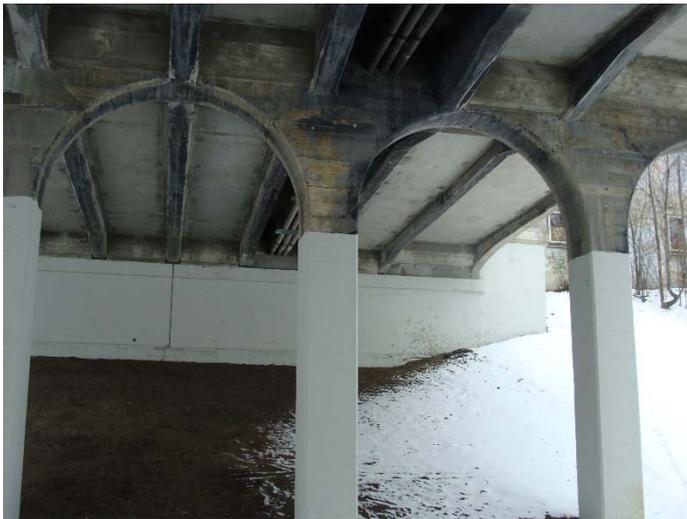
The piers columns and caps appear to be in good condition.

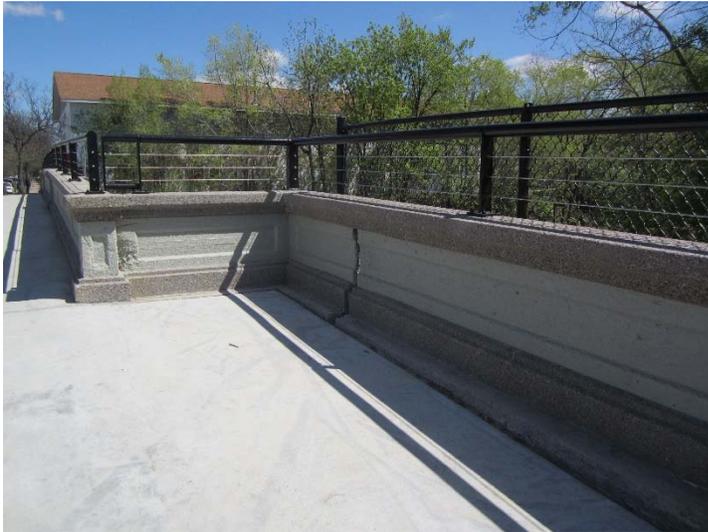
Railings and Sidewalks:

The railings are in satisfactory condition. This shows a typical wingwall condition. The panel adjacent to the corner post has poor concrete, but otherwise the rail is in good condition. The cable railing was installed in 2013 to add additional height to the railing.

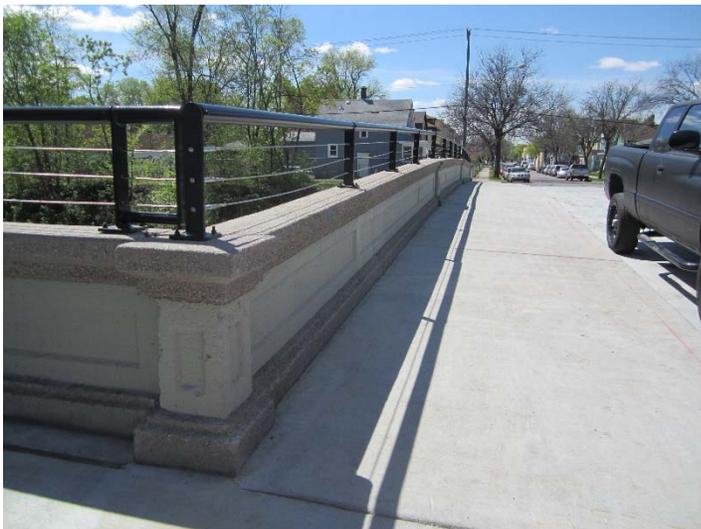
This is a typical post condition and also shows the typical bridge condition.

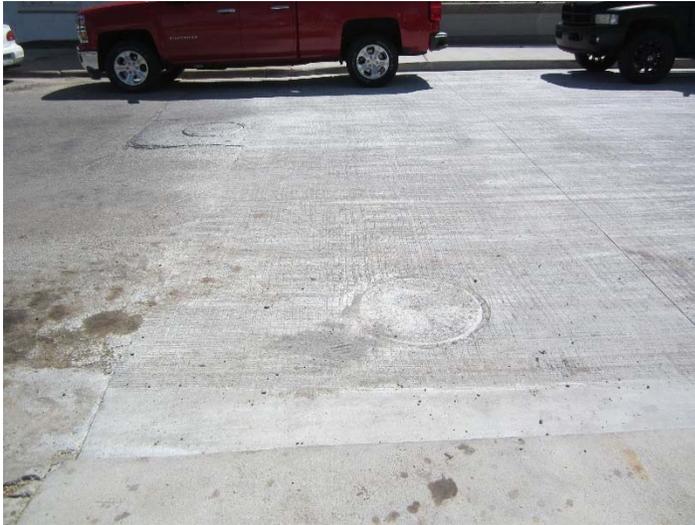
Approaches:

Concrete approach panels with 2 inches of wearing course are present. Two manholes can be seen in this picture. One is for the watermain and the other is to access the duct bank.

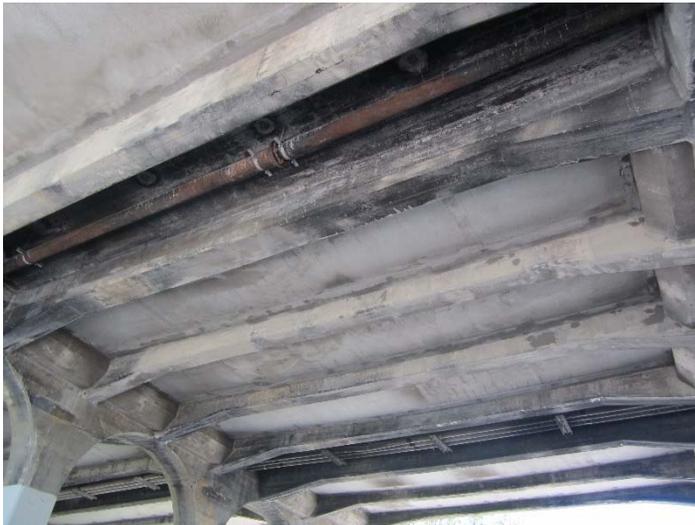
Non -Structural Condition:

A watermain is supported between the first two interior beams on the west side of the bridge and conduit is supported in the 3rd bay from the east.
