# What Causes Stripping Under Chip Seals

What to Do About It

MnDOT Office of Materials &  
Road Research

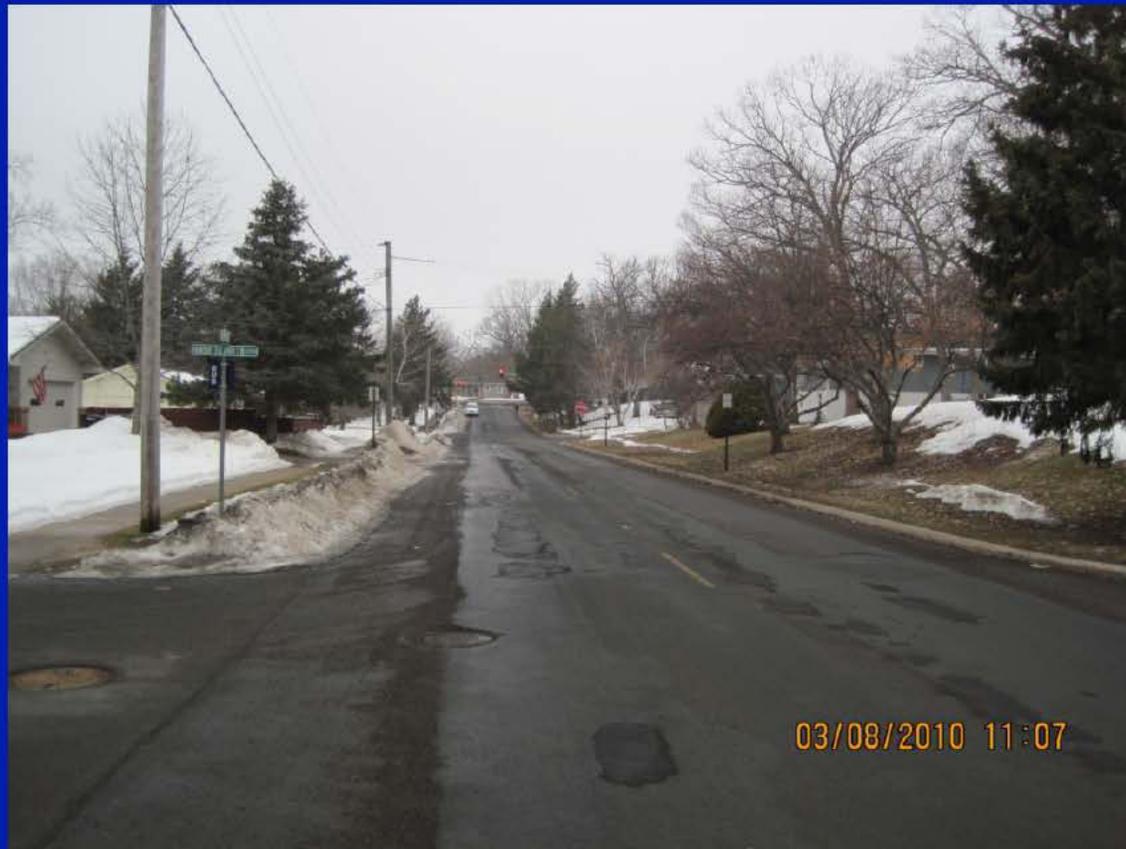
# Stripping Under Chip Seals

- Some streets develop potholes 2 to 3 years after chip seals are applied
- Starts as small blisters
- Grows to 1/2" to 1" deep potholes the size of pie pans or larger

- The wearing course seems to be destroyed
- Seems mainly to happen on curb and gutter streets

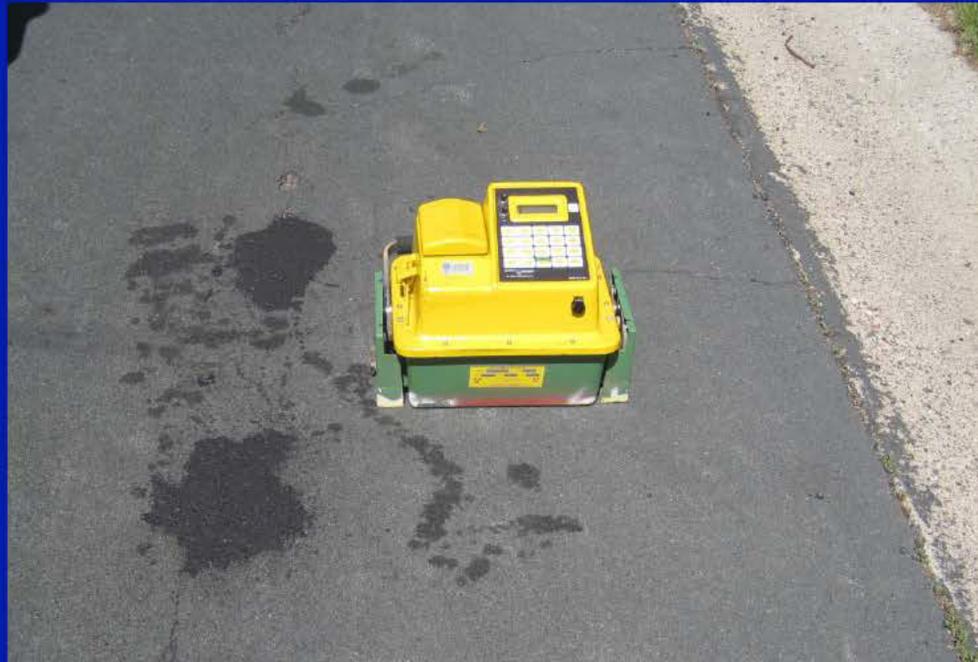
# Nuclear Density Tester

- Existing Streets
- Nuclear density tester will determine variability quickly
- Recommend chip sealing streets with less than 6 lbs. variability
- Chip sealing early in streets life seems to help

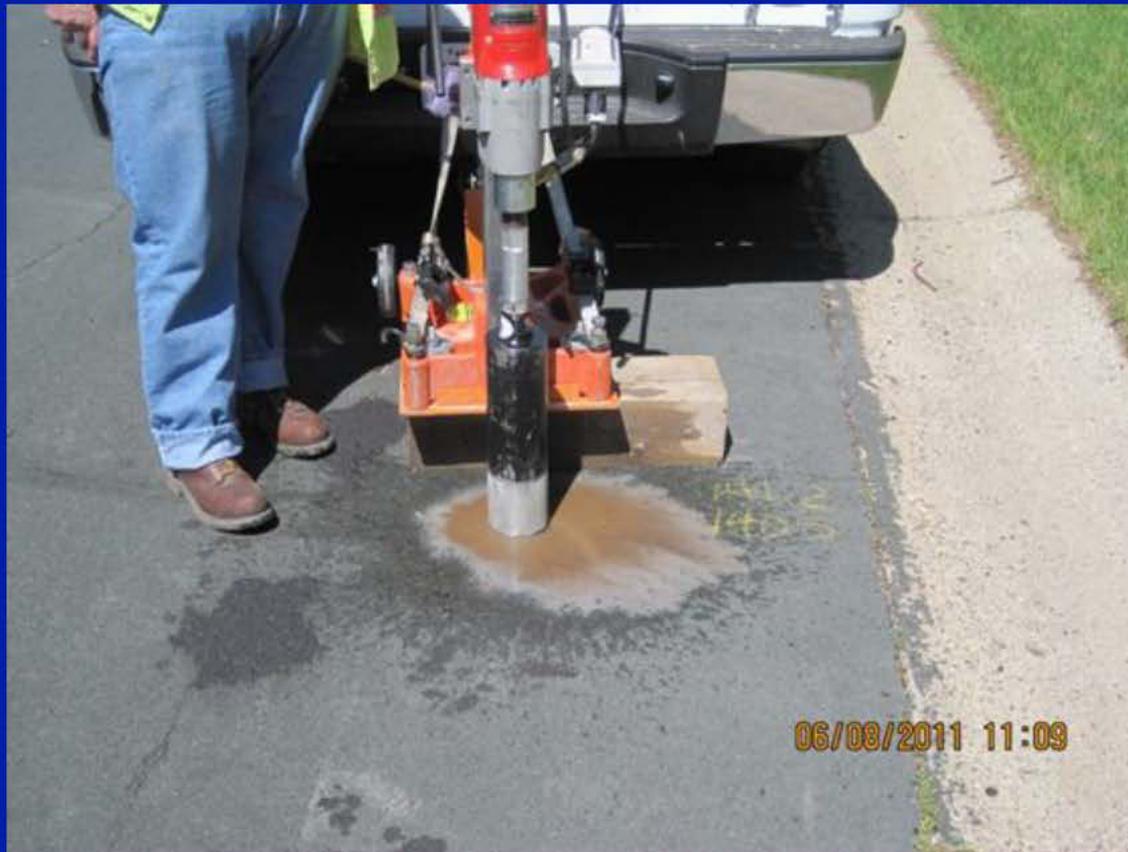
# Coring and Air Voids Testing

- Observed high variability in density of cores taken from streets with issues
- Then developed theory that high air voids makes mix more prone to stripping than mix with proper density

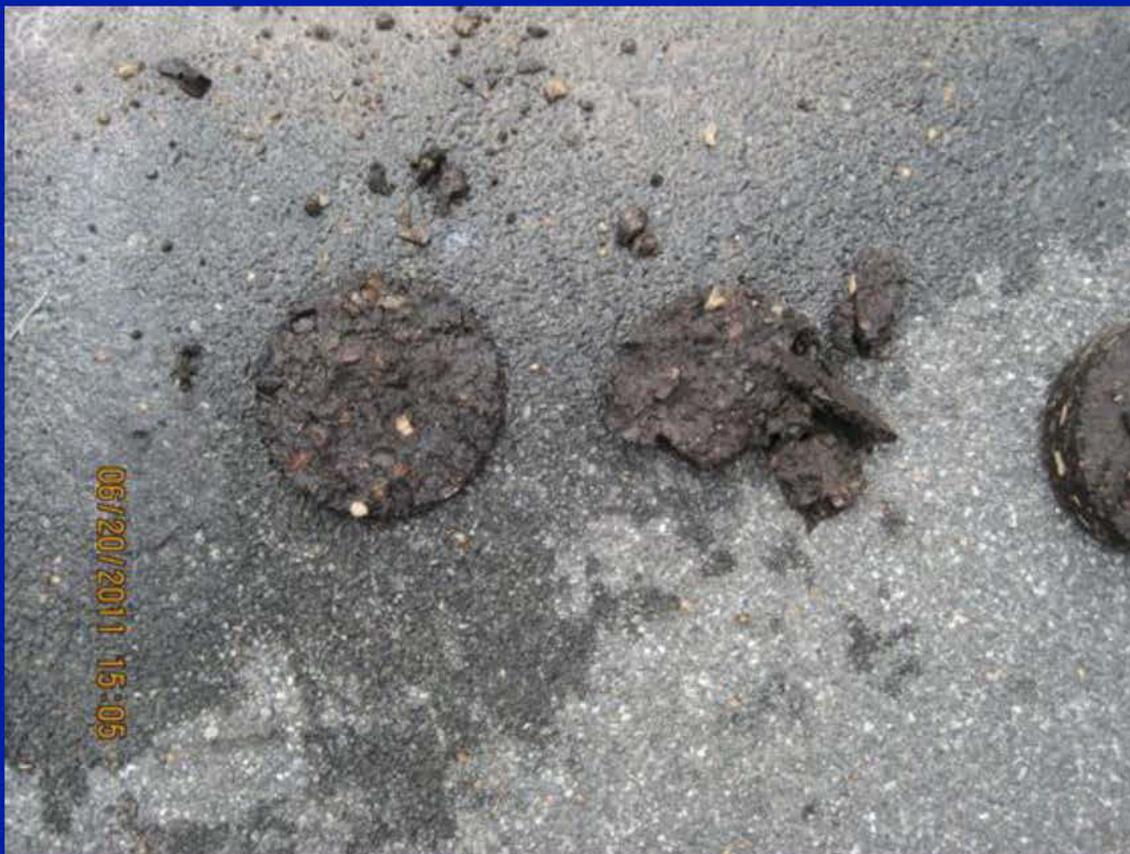
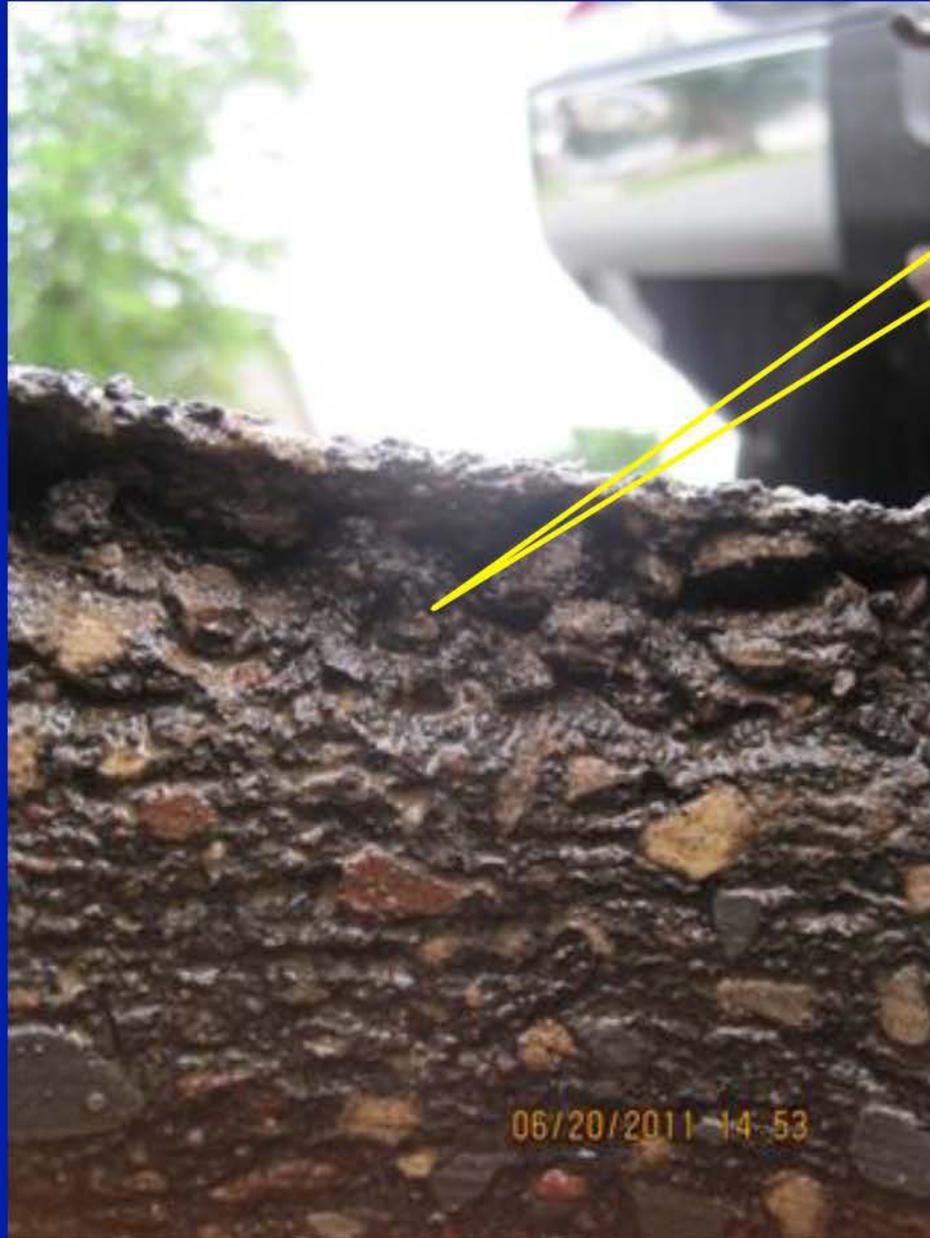
# Stripping

Area of Stripping

- Stripping is caused by high air voids
- Streets seem to have high degree of variability of density
- MnDOT has similar issues on longitudinal construction joints
  - Air voids from 10 to 16%
  - Chip sealing is not cause of the issues

- On new construction or re-paving
- Recommend switching from ordinary compaction to specified density
- Does not appear to increase cost of paving
- May increase cost of inspection
- Reserve right to pick coring locations

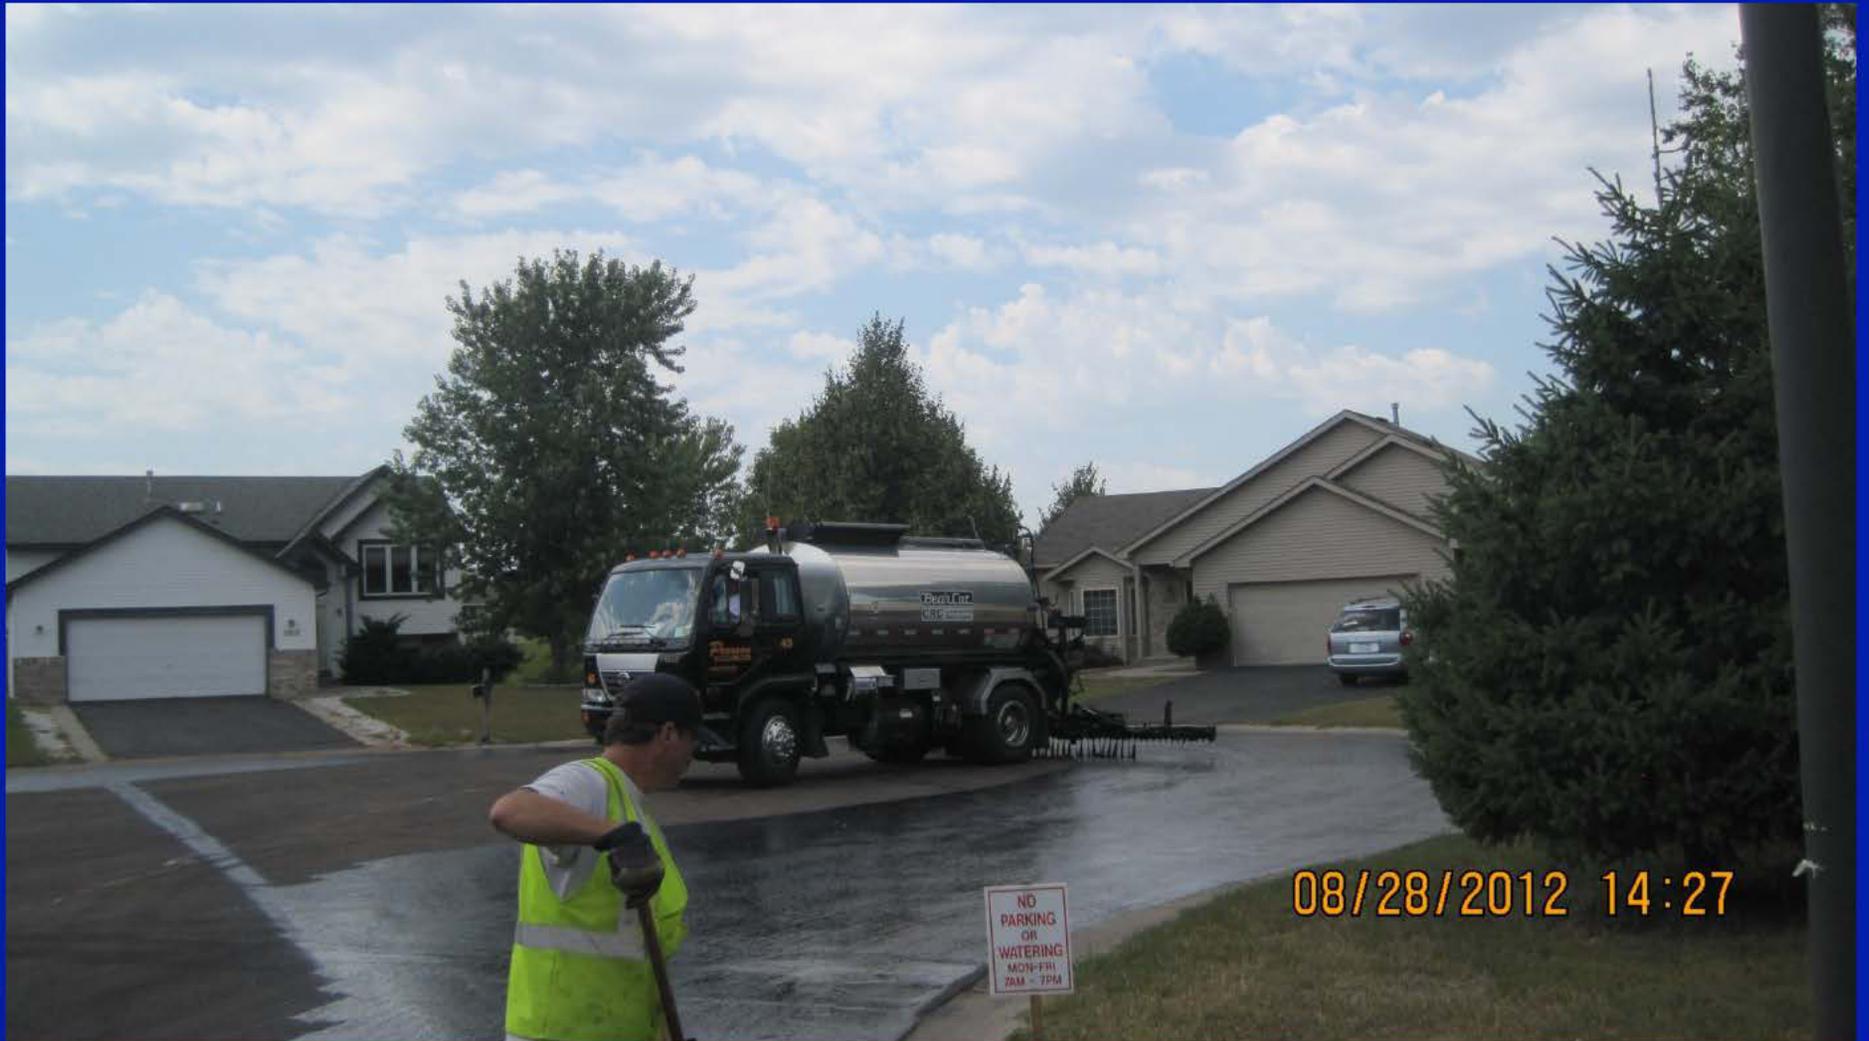
- Fog sealing may be an options
  - Seal water out
  - Allow water vapor to escape
