Rumble Strip Noise Study

Technical Report

Prepared for
Minnesota Department of Transportation
State Project Number 8816-2027

Prepared by
HDR Engineering, Inc.
701 Xenia Avenue South
Suite 600
Minneapolis, MN 55416

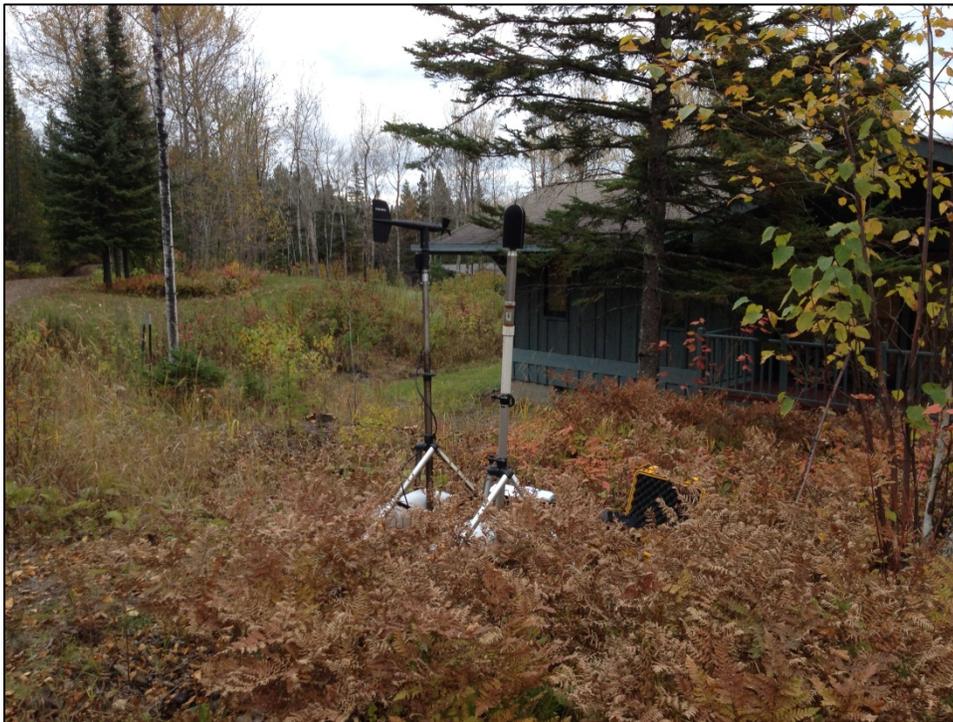
Figure 9-1. ML1 Monitoring Setup

Monitoring at ML1 occurred from Thursday October 24 to Saturday November 2, 2013. ML1 was located at a residence between TH 61 and Lake Superior, in an area with low vegetation. Line of sight with TH 61 was blocked by a wooden fence. Figure 9-1 shows the monitoring setup next to the residence.

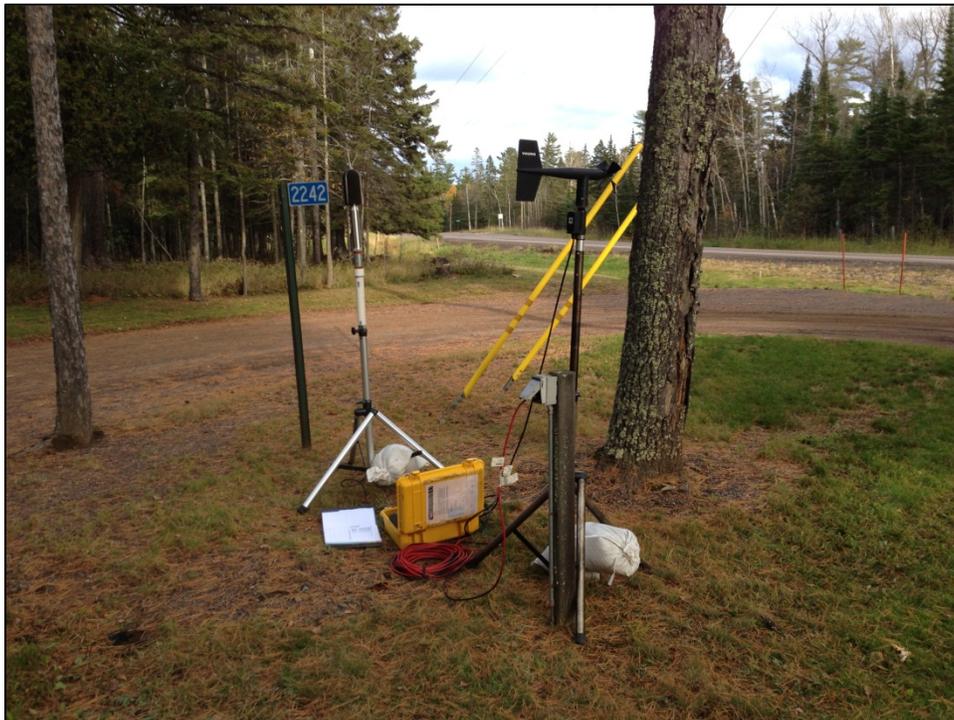
Figure 9-6. ML2 Monitoring Setup

Monitoring at ML2 occurred from Thursday October 24 to Saturday November 2, 2013. ML2 was located at a residence adjacent to the landside of TH 61. The monitoring equipment was located on a grassy patch within a circle driveway, and had direct line of sight with TH 61. Figure 9-6 shows the monitoring setup, the circle driveway, and the highway in the background.

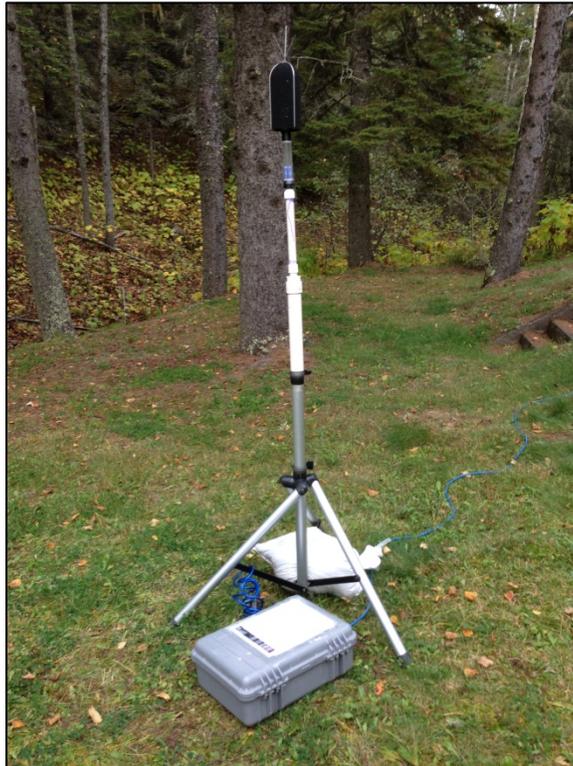
Figure 9-11. ML3 Monitoring Setup

Monitoring at ML3 occurred from Friday October 25 to Saturday November 2, 2013. ML3 was located at a lodge 900 feet from the lakeside of TH 61. The area was wooded, but the monitoring equipment was located on a grassy patch next to the landside of the lodge. Figure 9-11 shows the monitoring setup.

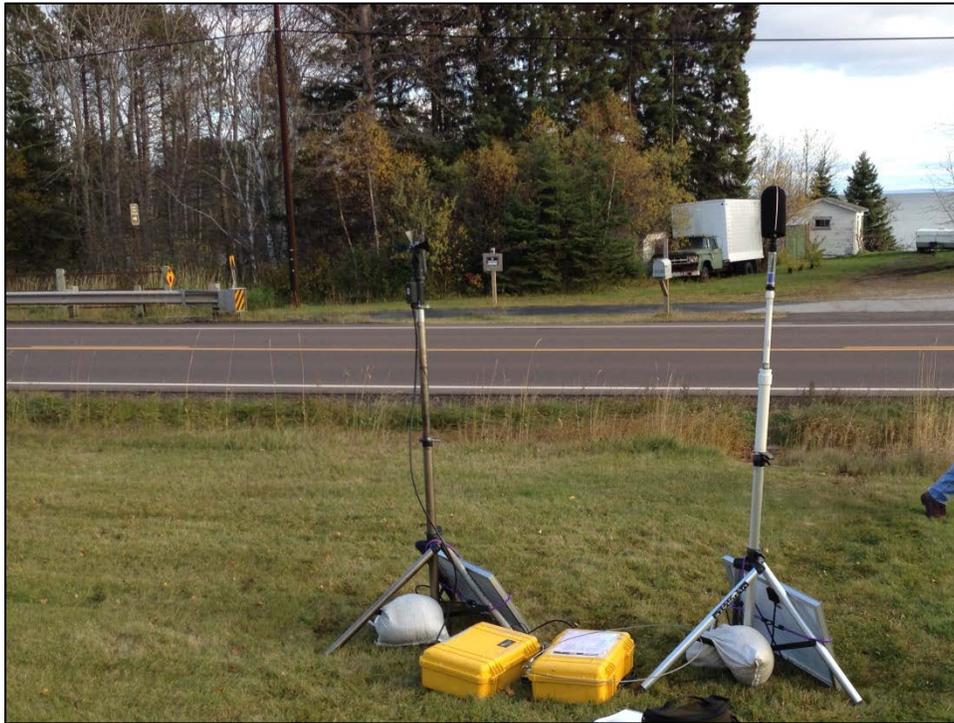
Figure 9-16. ML4 Monitoring Setup

Monitoring at ML4 occurred from Friday October 25 to Thursday October 31, 2013. The monitoring period was cut short due to technical difficulties with the monitoring equipment. ML4 was located at a residence directly on the landside of TH 61. The monitoring equipment was located on a grass lawn with direct line of sight with TH 61. Figure 9-16 shows the monitoring setup and the highway.

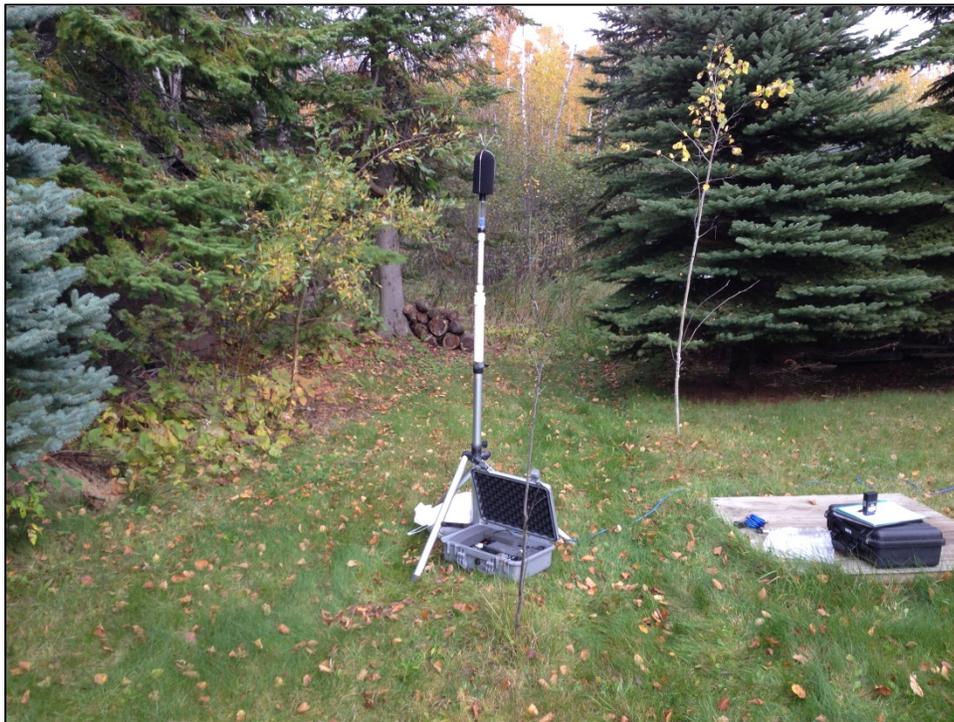
Figure 9-21. ML5 Monitoring Setup

Monitoring at ML5 occurred from Thursday October 17 to Thursday October 24, 2013. ML5 was located at a residence downhill from the lakeside of TH 61. The monitoring equipment was located on a grass lawn on the highway-side of the residence. A wooded area with a bike trail separated the residence and the highway. Figure 9-21 shows the monitoring setup.

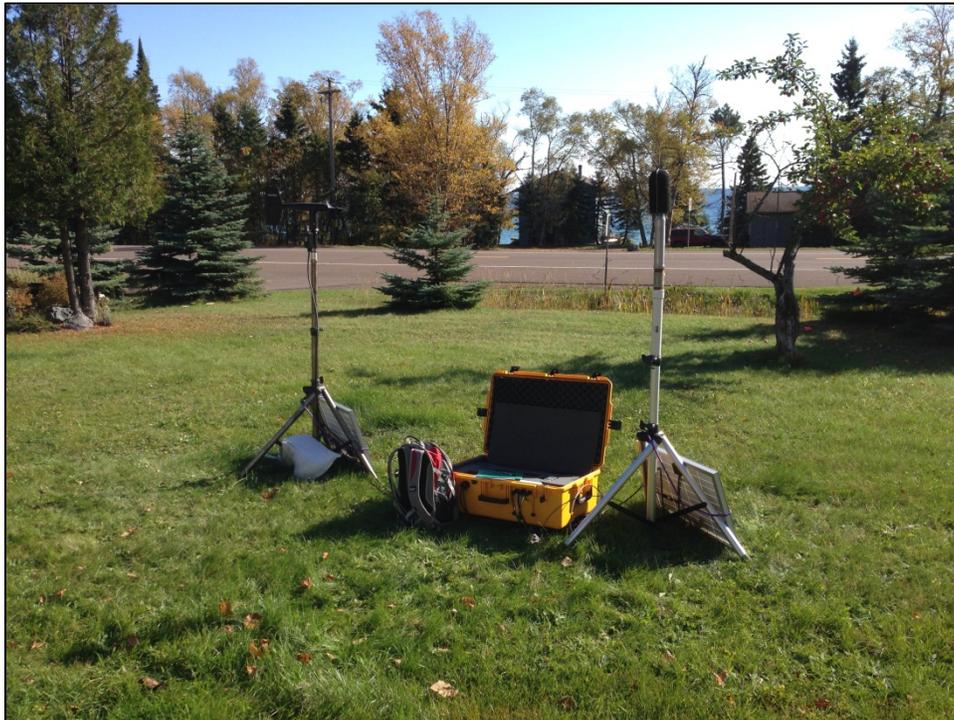
Figure 9-26. ML6 Monitoring Setup

Monitoring at ML6 occurred from Wednesday October 16 to Wednesday October 23, 2013. ML6 was located at a residence directly on the landside of TH 61. The monitoring equipment was located on a grassy patch within a circle driveway, and had direct line of sight with the highway. Figure 9-26 shows the monitoring setup and TH 61.

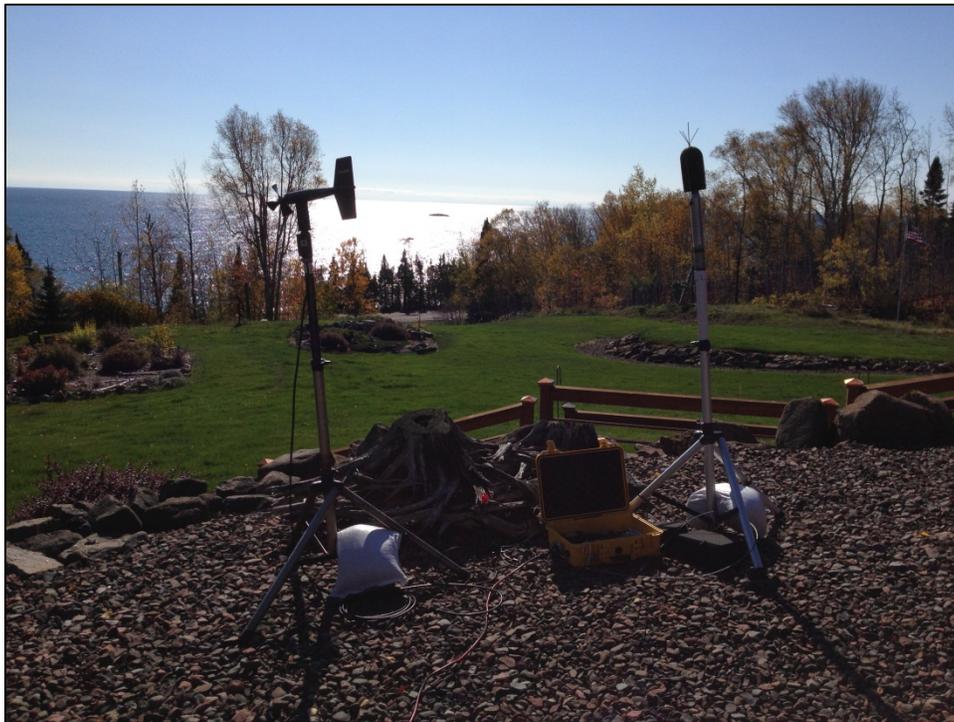
Figure 9-31. ML7 Monitoring Setup

Monitoring at ML7 occurred from Wednesday October 16 to Wednesday October 23, 2013. ML7 was located at a residence 450 feet from the landside of TH 61, and was uphill from the highway. The monitoring equipment was located on landscape rock, and had direct line of sight with a portion of the highway. Figure 9-31 shows the monitoring setup, and TH 61 can be seen in the background.

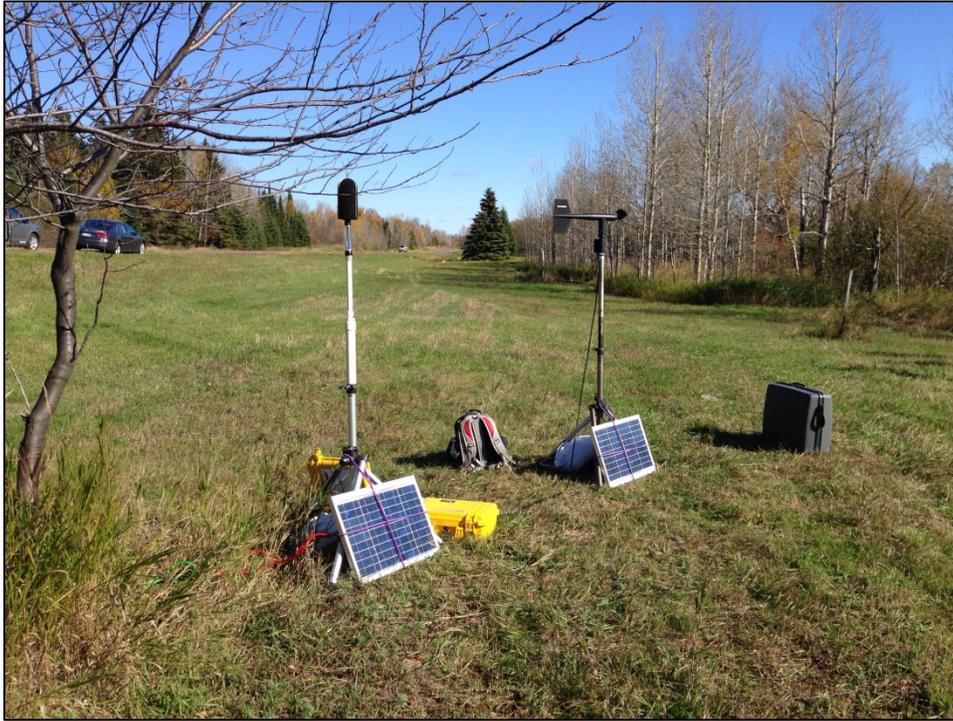
Figure 9-36. ML8 Monitoring Setup

Monitoring at ML8 occurred from Wednesday October 16 to Wednesday October 23, 2013. ML8 was located in a grassy clearing adjacent to the lakeside of TH 61, and was a few feet below pavement level. Figure 9-36 shows the monitoring setup and the highway in the background.

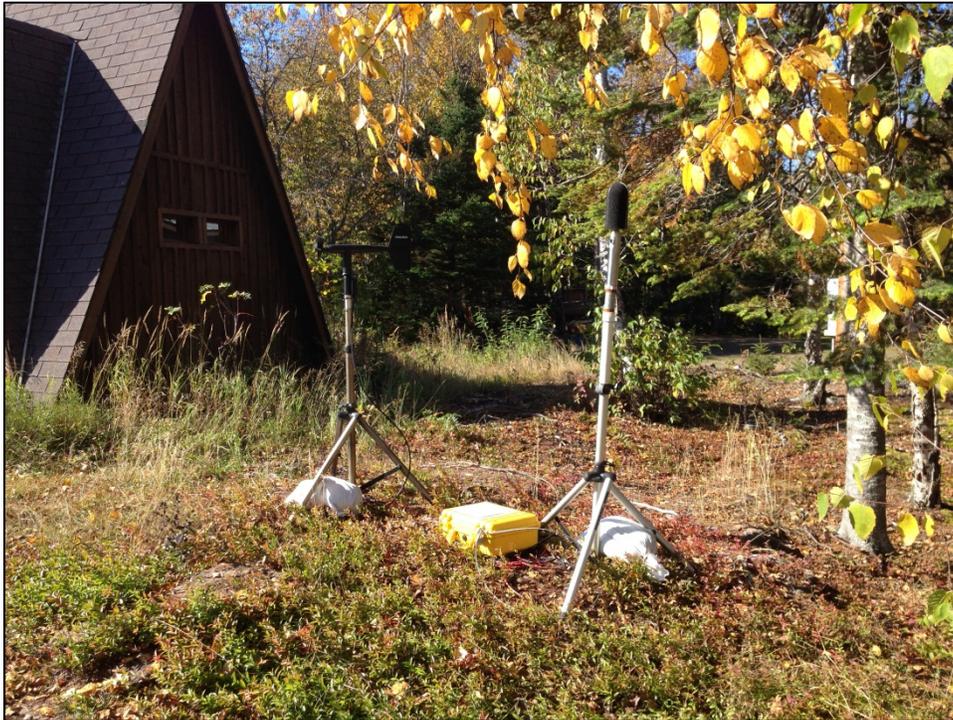
Figure 9-41. ML9 Monitoring Setup

Monitoring at ML9 occurred from Wednesday October 16 to Thursday October 24, 2013. A power outage combined with technical difficulties resulted in a two-day period when the monitoring system was non-operational. ML9 was located at a residence between TH 61 and Lake Superior. The area was wooded with no line of sight with the highway, and the monitoring system was placed on low vegetation. Figure 9-41 shows the monitoring setup and a shed on the residence.

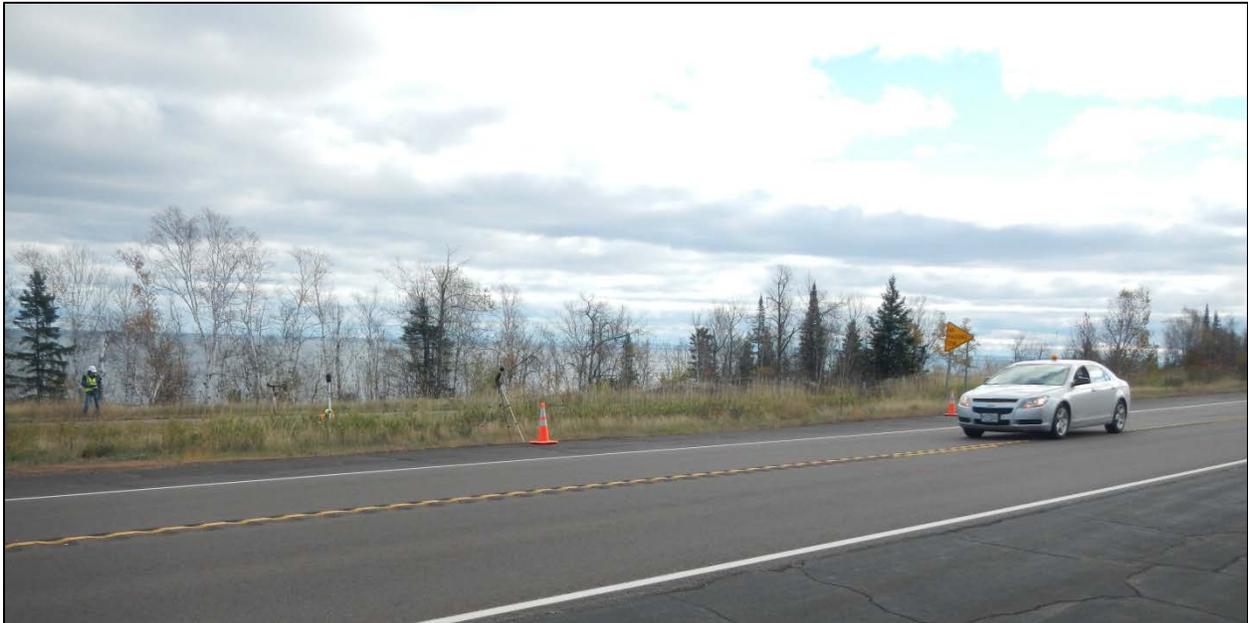
TH 61 had a slight slope at this location, and a bike trail was located approximately 90 feet from the highway (placing it between the highway and the 100-foot monitoring location). Opposite of the sound level meters was a vertical rock outcropping. Wet pavement is generally louder than dry pavement, so it was particularly important for the pass-by measurements to be made on dry pavement. The last precipitation event recorded at the Silver Bay Airport prior to the measurements occurred just after 12:00 a.m. on October 22, 2013. Gust wind speeds exceeding the recommended limit of 11 mph were measured during the control and merge maneuvers, but no wind distortion was present in the audio recordings. The handheld radar gun was unavailable during these measurements, so the general speeds of 45, 55, and 65 mph were assumed. Table 10-1 contains the L_{max} values measured at 25, 50, and 100 feet from the centerline of the road.

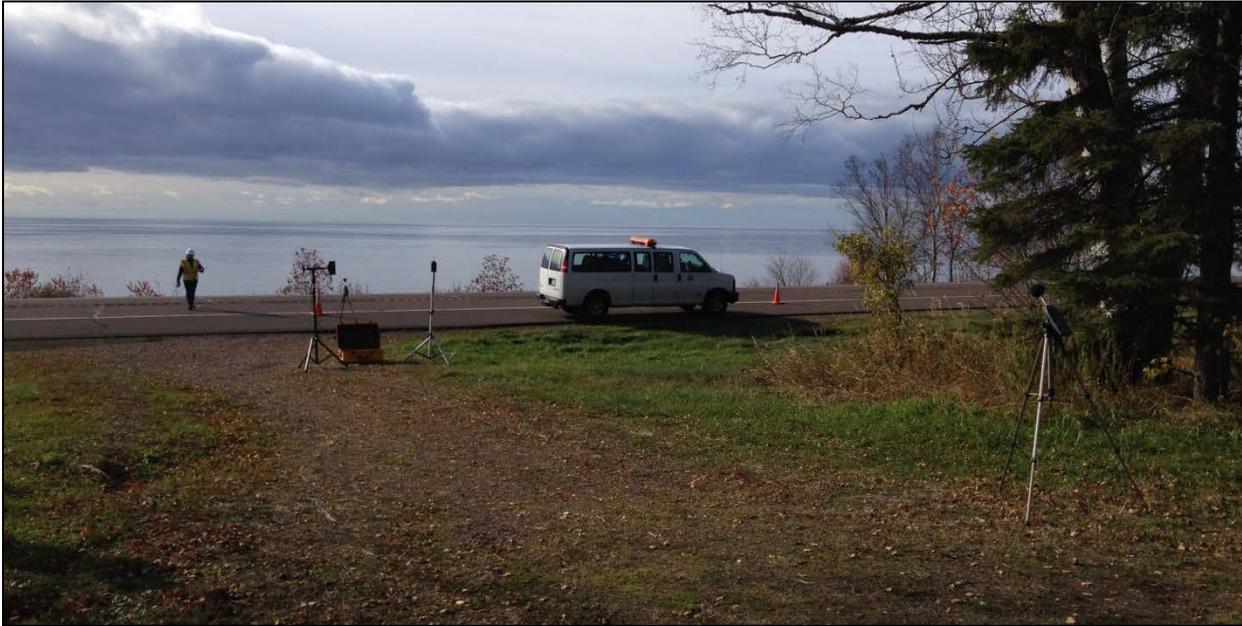
Figure 10-2. PB2 Monitoring Setup

PB2 was located on the landside of TH 61 between mile markers 115 and 116 north of Grand Marais. Monitoring occurred between 11:15 a.m. and 12:15 p.m. on Tuesday October 29, 2013. Figure 10-2 shows the monitoring location, which was a grass clearing between fairly thin lines of trees.

The line of trees did provide minor shielding for the 100-foot monitoring location, but the meter had direct line of sight to the full 100-foot measurement distance on the highway. The last precipitation event recorded at the Grand Marais Airport prior to the measurements occurred at 6:30 p.m. on October 27, 2013. The measured microphone-height wind speeds were below 11 mph during all measurements. Table 10-2 contains the vehicle speeds measured with the handheld radar gun and the measured L_{\max} values.

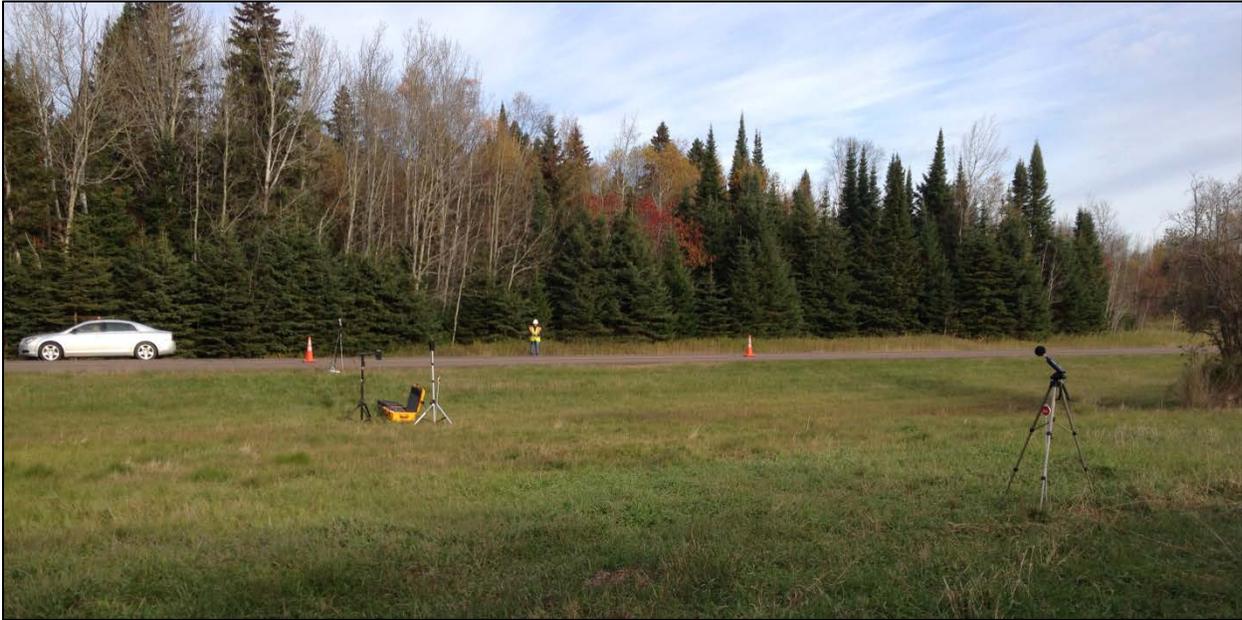
Figure 10-3. PB3 Monitoring Setup

PB3 was located on the lakeside of TH 61 between mile markers 121 and 122 north of Grand Marais. Monitoring occurred between 9:15 and 10:15 a.m. on Friday October 25, 2013. Figure 10-3 shows the monitoring location, which was a grass clearing at an elevation slightly lower than the pavement.
