Myers Field Airport (CNB)

December 2017

Since 1995, Federal grant assurances have required that to continue receiving Federal funding, airports implement a pavement maintenance-management program for any pavement constructed or repaired using Federal money. To help individual airports meet this grant assurance and improve the statewide airport system, the Minnesota Department of Transportation (Mn/DOT) Office of Aeronautics contracted with Applied Research Associates, Inc. (ARA) to provide pavement evaluation and management inspections at local airports. This report contains the results of the 2017 pavement inspections at Myers Field Airport (CNB).

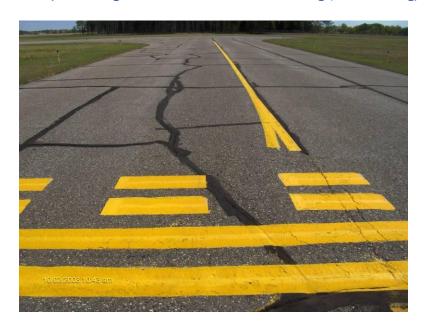
Example of Longitudinal and Transverse Cracking (L&T cracking)

Longitudinal and transverse cracks are caused by pavement aging, by construction, and by subsurface movement. Aging occurs as pavement loses some of its components to the atmosphere and becomes more brittle. Consistent application of pavement sealcoats can help to prevent the occurrence of age related cracks. Cracks will also develop along poorly constructed paving lane joints. Ensuring that joints are made when both sides are still hot, and near the same temperature, is one of the best ways to mitigate this potential problem. Seasonal movement caused by changes in moisture content or temperature differences can also cause pavement cracks. Asphalt pavement placed over a PCC pavement or cement stabilized base course may evidence reflective cracking from the underlying material. Longitudinal and transverse cracks are not caused by wheel loads, although traffic may worsen their condition.

Low severity longitudinal and transverse cracks are less than ¼ inch wide, or if sealed with suitable filler material in satisfactory condition can be any width, less than 3 inches, if they are not spalled. Maintenance usually is not indicated for low-severity cracking. Moderately spalled cracks and cracks wider than ¼ inch which are not satisfactorily sealed are at medium severity. Medium-severity cracks should be sealed with a high-quality crack filling material. Severely spalled cracks and cracks wider than 3 inches are at high severity. High-severity L&T cracks normally require patching.

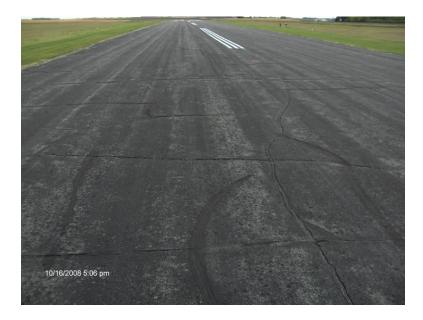
Example of Block Cracking

Block cracking is longitudinal and transverse cracking that has established a pattern of blocks ranging in size from 1ft x 1ft to 10ft x 10ft. This distress typically happens in older asphalt pavements and is an indication that the bituminous binder has lost most of its flexibility. The severity determination is basically determined by the crack width criteria defined for longitudinal and transverse cracking. Crack sealing typically is used to repair block cracking; however, the amount of required sealant can be extensive due to the high density of cracks.

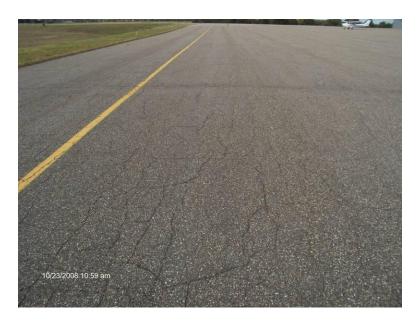
Example of Alligator Cracking

Alligator (or fatigue) cracks are a series of interconnected load-related cracks caused by fatigue of the asphalt surface. Alligator cracking is a significant structural distress and develops only in places subject to traffic loads. These cracks typically initiate at the bottom of the asphalt layer (where tensile strains

are highest) and propagate upward - so once a fatigue crack is visible, significant damage has already occurred.

At low severity, alligator cracks are evidenced by a series of parallel hairline cracks (usually in a wheel path). Further traffic and deterioration leads to the interconnection of these cracks. Medium severity alligator cracking is a well-defined pattern of interconnected cracks, some spalling may be present. High severity alligator cracks have lost aggregate interlock between adjacent pieces, the cracks may be severely spalled with FOD potential, and most likely the pieces will move freely under traffic. Alligator cracking is a structural failure and cannot be repaired with sealant, the proper repair is full-depth patching.

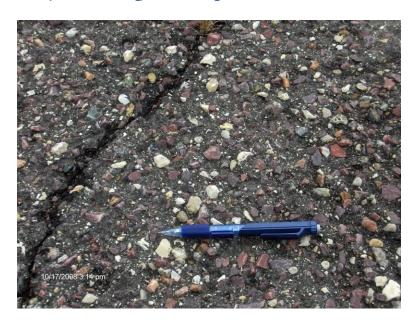
Example of Raveling/Weathering

Raveling and weathering are the wearing away of the pavement surface. Raveling is the condition where the mid- to large size aggregates are becoming dislodged; weathering is when the fine aggregate wears away exposing the edges of the larger aggregate. These distresses are usually evident over large areas and may occur together (pictured above) or separately. Raveling and weathering may indicate that the asphalt binder has hardened significantly.

Raveling – At low severity, the number of missing coarse aggregates (> 3/8 inch) is between 5-20 missing/yd², medium severity (pictured below where the missing coarse aggregates have been dotted with yellow paint) is 21-40 missing/yd², and high severity is > 40 missing/yd².

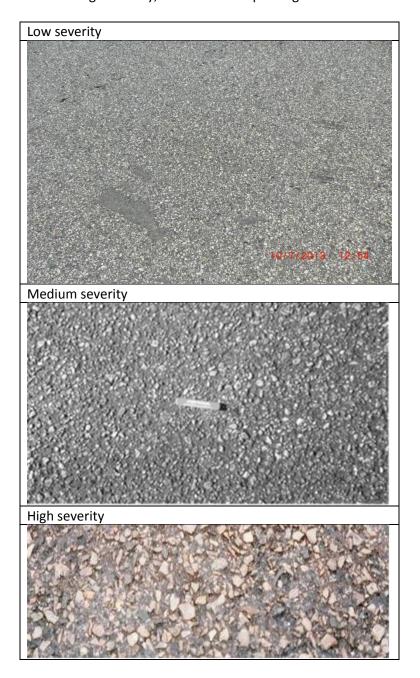
Weathering – At low severity, the coarse aggregate is slightly exposed due to the wearing away of the fine aggregate. At medium severity, the coarse aggregate is exposed up to ¼ the width of the longest side. At high severity, the coarse is exposed greater than ¼ the width of the longest side.

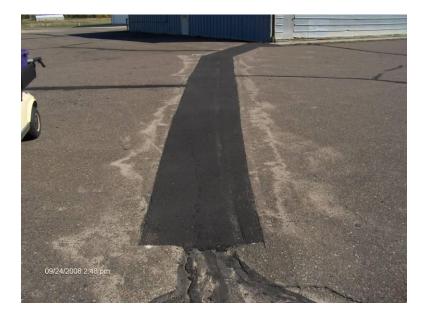
Example of Patching

Patched areas are defined when a portion of the original pavement is replaced with a material intended as a semi-permanent repair. A patch is documented as a defect because it is considered a break in the integrity of the pavement structure. Patches are constructed for a variety of reasons including utility repairs, correcting grade issues, and addressing a defect in the original pavement. The severity level of patches is determined by the amount of distress (i.e. cracking, depression, weathering/raveling, etc.) occurring within the limits of the patched area.

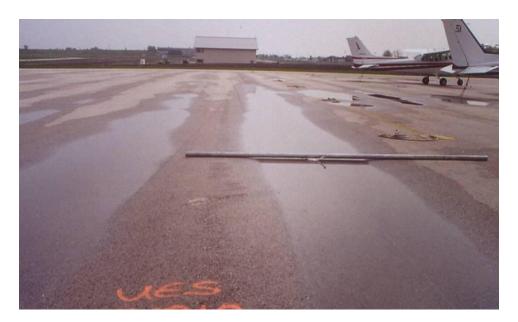
Example of Rutting

Ruts are localized, load related, areas of pavement having elevations lower than the surrounding sections. Rutting is due to base and subgrade consolidation, caused by excessive wheel loads or poor compaction. Ruts indicate structural failure, and can cause hydroplaning. At low severity, ruts have an

average depth of $\frac{1}{2}$ to $\frac{1}{2}$ inches. At medium severity, ruts have an average depth of $\frac{1}{2}$ to $\frac{1}{2}$ inch. High severity, ruts have an average depth greater than $\frac{1}{2}$ inch. Full-depth patching is the appropriate repair for ruts.

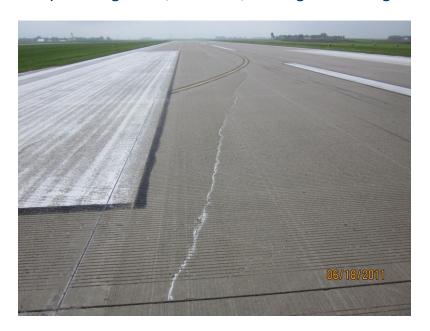
Example of Longitudinal, Transverse, and Diagonal Cracking

LTD cracking is most often a result of externally applied loads and/or constrained temperature deformations. External loads cause LTD cracking through flexure. Temperature changes on restrained slabs will result in stresses due to friction or curling. When any of these stresses exceed the strength of the slab, cracking will occur. LTD cracking is recorded at low, medium, or high severity, depending on the width of crack opening and degree of deterioration. At low severity, the crack is less than 1/8th inch wide with little spalling and no corrective action is indicated. At medium severity, LTD cracks can be up to 1 inch wide with moderate spalling, and should be repaired and sealed using procedures similar to joint sealing. At high severity, cracks exceed 1 inch in width and may be severely spalled. High-severity LTD cracking is evidence of serious load failure of the slab, and correction may require patching or slab replacement. If the distress occurs in several adjacent slabs at medium or high severity, major rehabilitation of that pavement area is indicated.

When a slab is divided by LTD cracks into four or more pieces, the slab is said to be "divided" or "shattered." Shattered slab is a separate distress category and is indicative of significant structural failure as the slab loses its ability to distribute loads to subgrade and further slab deterioration can be expected. Shattered slabs are rated in three severities, with slab replacement recommended for medium and high severities.

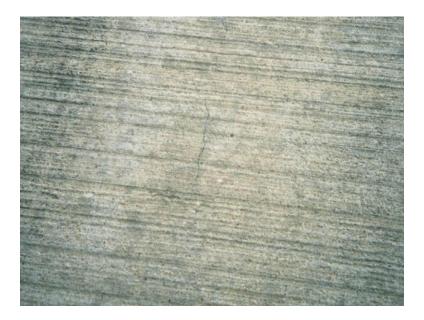
Example of Shrinkage Cracking

Shrinkage cracks are small, nonworking (no spalling along edge) cracks that are visible at the surface but do not penetrate through the full depth of concrete. Shrinkage cracks most commonly occur shortly after construction due to concrete shrinkage during the curing process. Shrinkage cracks are usually so small that they are not visible until staining or material loss at crack edges begins to take place. Shrinkage cracks do not represent a structural weakness, and no corrective action is prescribed.

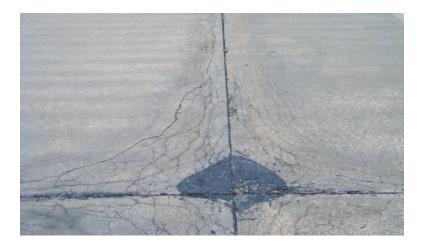
Example of Durability Cracking

Durability cracking (D-cracking) is caused by environmental factors, the most common of which is freezing/thawing. It usually appears as a pattern of hairline cracks running parallel to a joint or crack, or in a corner, where water tends to collect. This type of cracking eventually leads to disintegration of the pavement, creating FOD potential. At low severity, D-cracking is evident, but no disintegration has occurred. As the distress advances to medium severity, the distress pattern is evident over a significant area of the slab, and some disintegration and FOD potential exists. High severity durability cracking is evidenced by extensive cracking with loose and missing pieces and significant FOD potential.

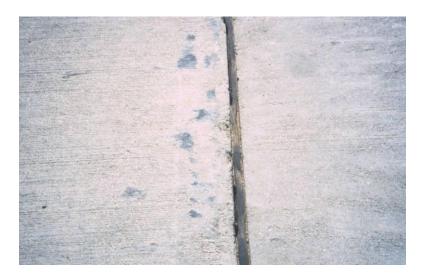
Example of Joint Seal Damage

Joint seal damage is recorded at three severities: low, medium, and high. When joint sealant is in perfect condition (no damage), it is not a distress. At low severity, at least 10 percent of the sealant is debonded but still in contact with the joint edges (i.e., joint sealant is in serviceable condition but should

be monitored for evidence of more serious failure). Medium-severity joint seal damage is recorded when at least 10 percent of the sealant has visible gaps smaller than 1/8th inch and is an indicator that replacement should be programmed as soon as is practicable. In the meantime, aggressive inspection and sustaining maintenance is recommended to minimize subsurface damage from moisture penetration. At high severity, visible gaps exceed 1/8th inch and the amount and degree of joint seal damage is such that repair is no longer feasible. The only appropriate corrective action is sealant replacement.

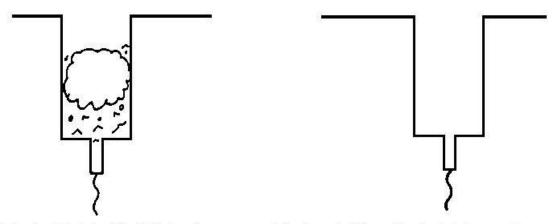
Typical joint with deficient sealant and a collection of debris & incompressibles.

Rout out old sealant, debris and incompressibles. Clean joint sides to expose fresh, clean concrete and stone. Retain existing reservoir shape.
