UNDERWATER BRIDGE INSPECTION REPORT

STRUCTURE NO. 27B60

LOWRY AVENUE

MINNESOTA DEPARTMENT OF TRANSPORTATION
UNDERWATER BRIDGE INSPECTION

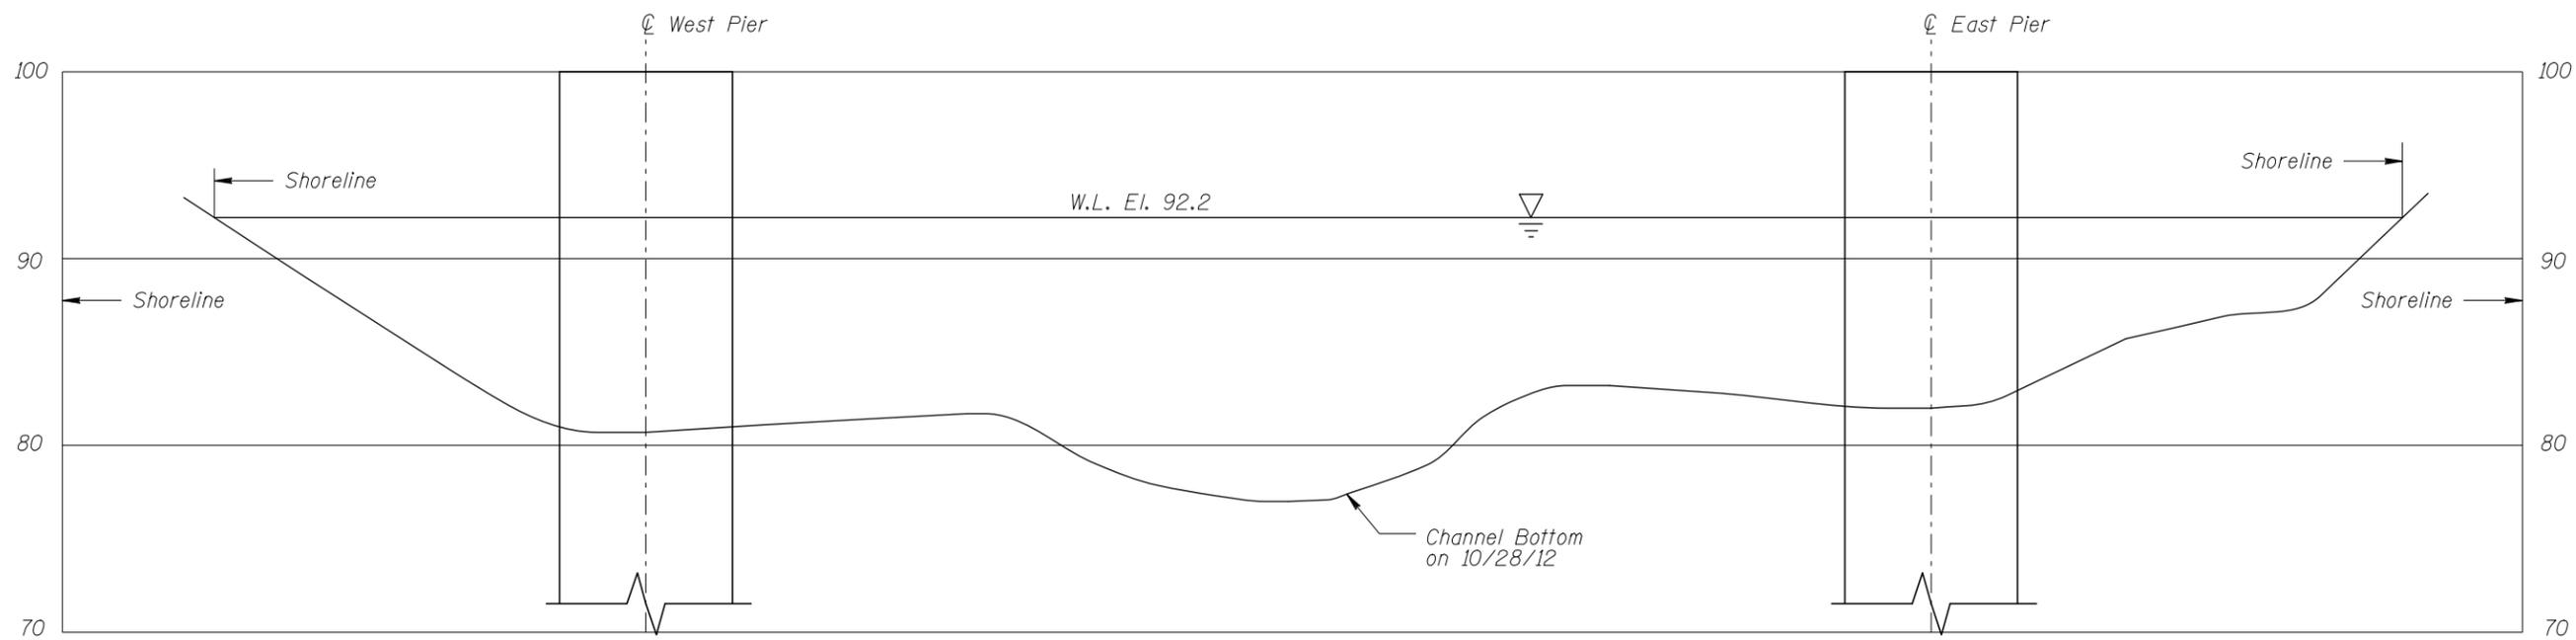
UPSTREAM FASCIA PROFILE

REMARKS: Overall, the concrete piers were found to be in very good condition with no defects of structural significance observed. Moderate to heavy timber debris accumulation was observed along the West Pier. The concrete surfaces were smooth and sound. The channel bottom appeared stable with no significant scour.

Monitor accumulation of timber debris, and if found to be increasing to an excessive extent, removal operations may become warranted at that time.
